# Utilities Commission of the Northern Territory

Independent Investigation into the 12 March 2014  
Darwin Katherine System Black

April 2014

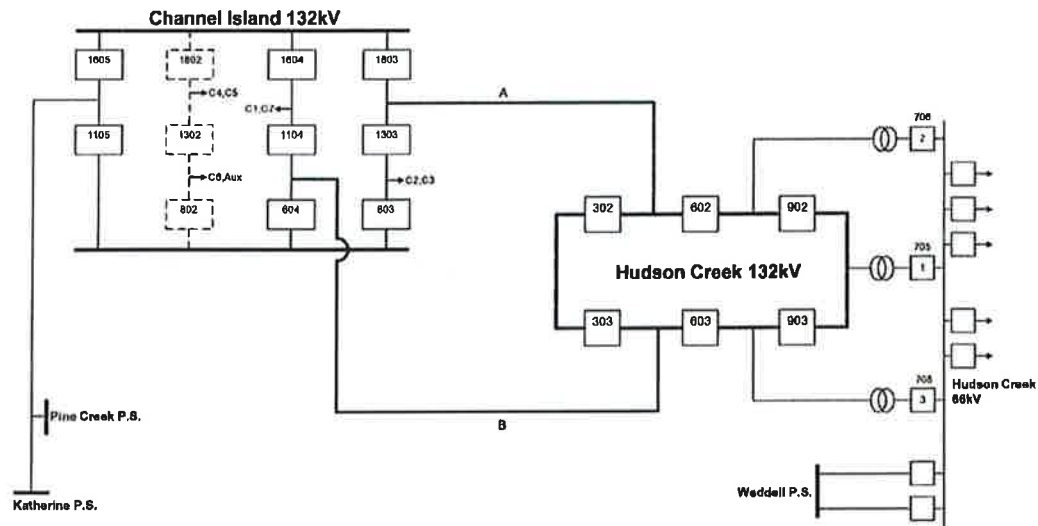
**Figure 3.1: Backbone of the Darwin 132kV System**

Figure 3.1 outlines the backbone of the Darwin – Katherine 132kV system and identifies the relevant circuit breakers and transformers.

The switching sequence defined in the PRI first required CB 66HC705 (i.e. circuit breaker 66kV Hudson Creek 705, labeled 705 in the diagram above) on the low voltage side of the transformer to be opened, and this operation was successfully performed. The next step in the sequence (although incorrect as the wrong circuit breaker was specified) was to open CB 132HC602 (i.e. circuit breaker 132kV Hudson Creek 602, labeled 602 in the diagram above). This circuit breaker is a three pole unit (one pole for each phase) where successful operation requires that all three poles operate in synchronism. The operation in this case was unsuccessful, as one of the three poles (white phase) failed to open. This situation initiated a Pole Discrepancy Alarm in the Hudson Creek control room, but does not initiate the operation of any equipment, including protection devices. At this stage Line A from Channel Island to Hudson Creek was carrying normal power over all three phases. At Hudson Creek Substation, the white phase current from Line A could pass through CB 132HC602 or CB 132HC302, while the red and blue phases could only pass through CB 132HC302. Line B was carrying normal current on all three phases. During this stage the system was stable, but at risk from a single contingency.

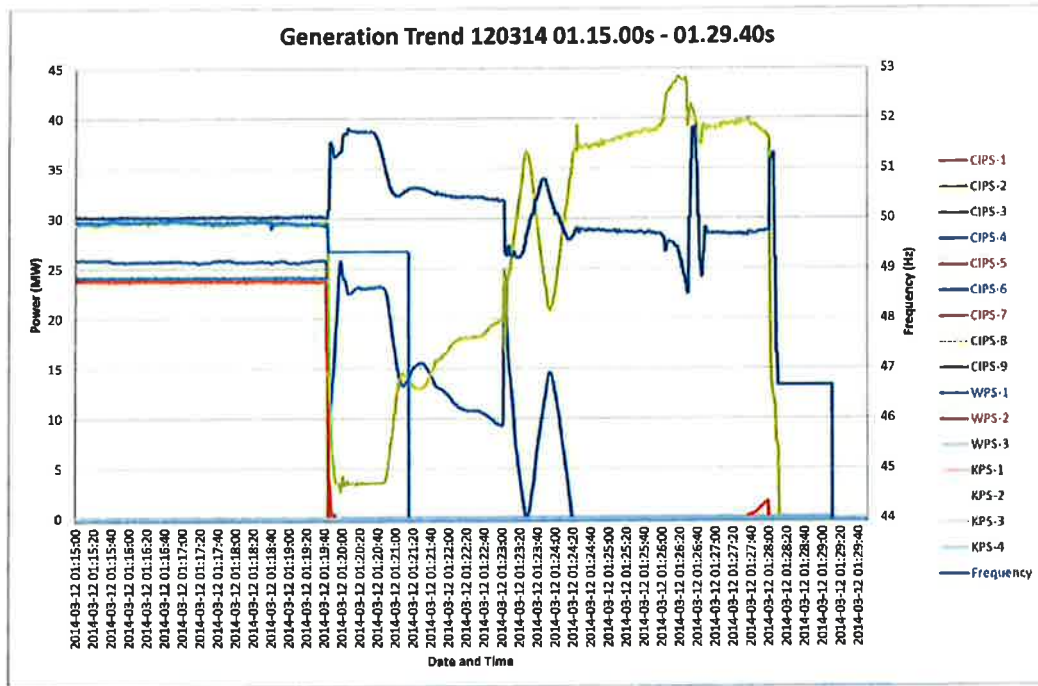
**Figure 3.2: Unit loadings on the Channel Island and Weddell Power Station Units<sup>1</sup>**

- Units 4, 5, 6 and 8 at CIPS were disconnected from the Darwin Network, but stayed at synchronous speed supplying the station auxiliaries and the Katherine load. Units 4 and 5 continued to provide some heat input into the Heat Recovery Steam Generators (HRSG) while maintaining full speed at no load until 01.21.52 when their generator circuit breakers opened on reverse power. As a result, Unit 6 could only continue to operate for a limited period of time, as the heat inertia in the HRSG was exhausted. Unit 6 was manually tripped by PWC Generation operators when the steam quality deteriorated to an unsafe condition. Just prior to being tripped Unit 6 had significant load excursions as it tried to control pressure in the HRSGs, which imposed mirror image load changes on Unit 8, see Figure 3.2.

Figure 3.2 shows the loading on the Channel Island and Weddell machines prior to the incident and through to the System black event.

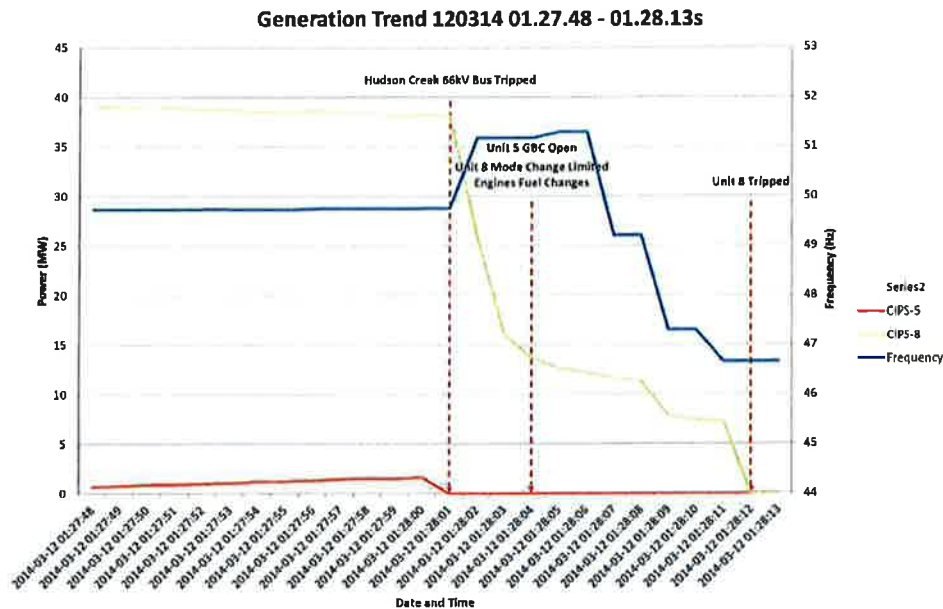
Figure 6.1: Generation Trends<sup>2</sup>

Table 6.1 sets out the chronology of the main events at Channel Island. Throughout this period Unit 8 in particular responded well, and would have provided a foundation to rebuild the system if the 66kV bus at Hudson Creek had not been stripped, see Figure 3.2.

Figure 6.1 shows the effect of stripping the 66kV bus at Hudson Creek on the two units on line at Channel Island Power Station. Unit 5 had only just synchronized and was increasing load to get to a stable operating point. Unit 8 was losing load as Unit 5 took load to maintain frequency at 49.73hz. It appears that Unit 5 lost load 1 second prior to the loss of the last 66kV feeder at Hudson Creek, but that is likely to be a data anomaly. Both Unit 5 and Unit 8 would have unloaded as the frequency increased due to the loss of load, as Figure 6.1 shows for Unit 8. However Unit 8 did not respond to the falling frequency as would normally be expected. This is probably the result of the mode change imposed by the control system which limited engine fuel changes. The importance of the operators understanding the conditions that trigger these mode changes and their consequences is highlighted by these events, as without that mode change Unit 8 may have been able to avoid an under frequency trip.

Consideration should be given to allow the control system to trip Unit 6 in the event that Units 4 and 5 trip, as its output can fluctuate significantly as it operates in pressure control mode to control pressure in the HRSGs, see Figure 3.2. This could de-stabilise the other units on the system, and in any case this unit can only provide a response for a short period of time without the gas turbines providing heat to the HRSGs. On this occasion Unit 8 did respond to minimize the effect of the variations of output from Unit 6.

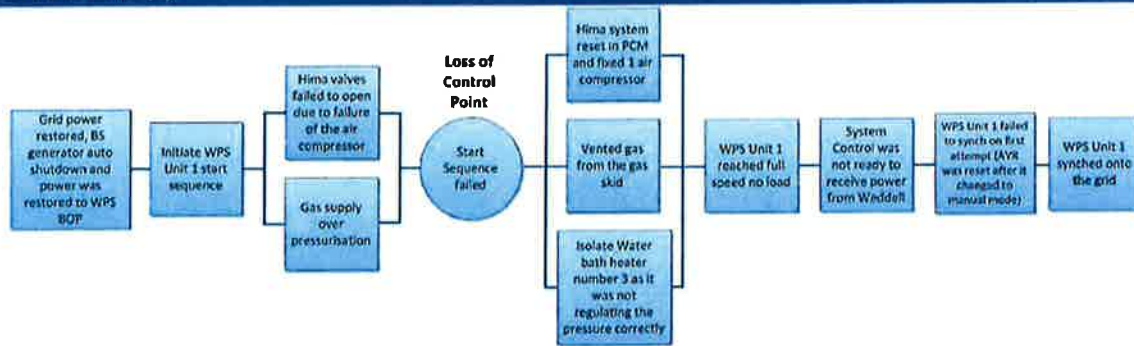
## Weddell Unit 1:

- ~5:34 – Unit 1 restart lock out automatically reset.
- 7:53:36 – Unit 1 66kV power supply was restored.
- 8:10:47 – Attempted the first Unit 1 start which failed at 8:15:31 due to high gas pressure as the gas pressure regulating valve does not completely shut off the gas flow as they should.

- Between 8:15:31 and 9:49:56, Unit 1 failed to start on four more occasions due to high gas pressure and on three occasions as the circuit breaker in the igniter circuit was in the open position.

- 10:00:41 – Unit 1 started successfully and reached full speed but tripped at 11:14:31 on loss of Motor Control Centre (MCC) power. A control fault prevented synchronisation, probably the AVR issue noted below.

- 11:22:37 – Unit 1 was restarted but tripped at 11:25:20 due to high gas pressure.
- 12:12:20 – Unit 1 was started successfully but was shut down after it failed to synchronise as the AVR was left in "Manual" rather than "Auto". Again this is similar to the black start generator issue and poor practice. These issues should have been discovered during pre-start checks that would be expected after an event such as this.

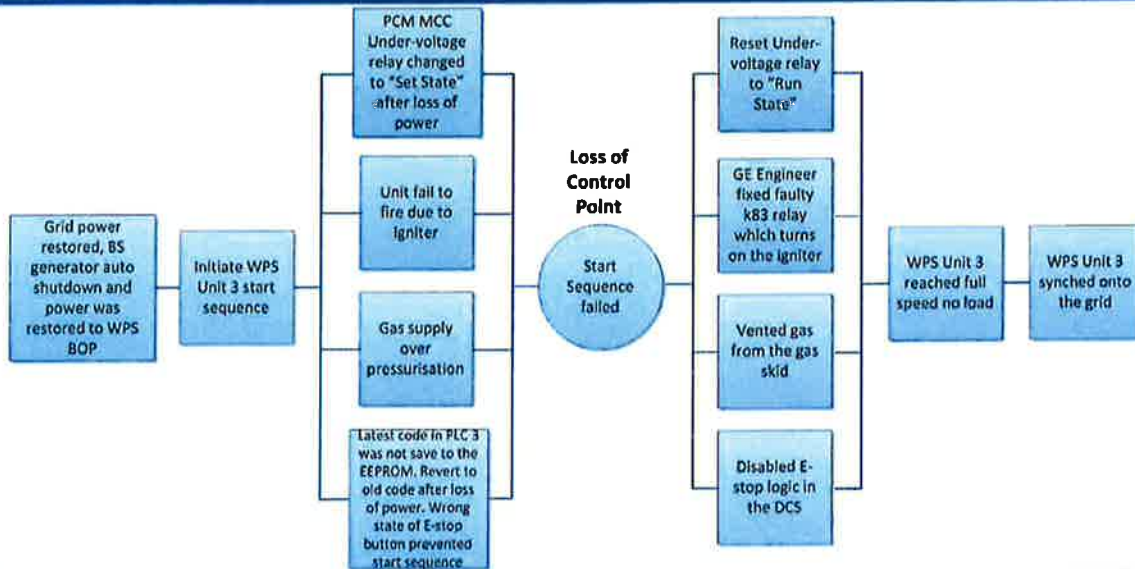
## Weddell Unit 3:

- 7:54:08 – Unit 3 66kV power supply was restored.
- 8:40:59 – Unit 3 control system restarted.
- 8:54:34 – Attempted the first Unit 3 start which failed at 8:56:05 due to high gas pressure.
- 9:01:43 – Unit 3 restart attempted but failed at 9:05:01 due to HIMA purge cycle failure. (The HIMA system is a parallel control system on the gas supply system to comply with Australian Standards, and the purge cycle is to ensure there is no residual gas in the machine prior to the introduction of gas during a start).
- Between 9:15:18 and 11:27:46 – Unit 3 failed to start on five more occasions due to HIMA purge cycle failure.
- 11:49:52 – Unit 3 was successfully started and synchronised to the grid.
