Standards of Service 2010-11

Key Service Performance Indicators

OCTOBER 2011

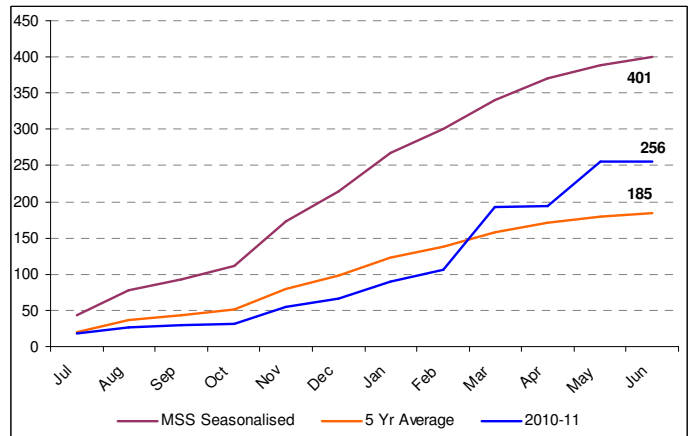
Graphs 4 to 7 demonstrate the accumulated SAIDI minutes from 2010-11 for each region along with the previous 5 year average (2005-06 to 2009-10) and the 'seasonalised' target value. The 'seasonalised' values have been determined by converting the annual Minimum Standard of Service (MSS) into cumulative monthly values based on a 5 year average historical contribution of each month's reliability performance to the annual total.

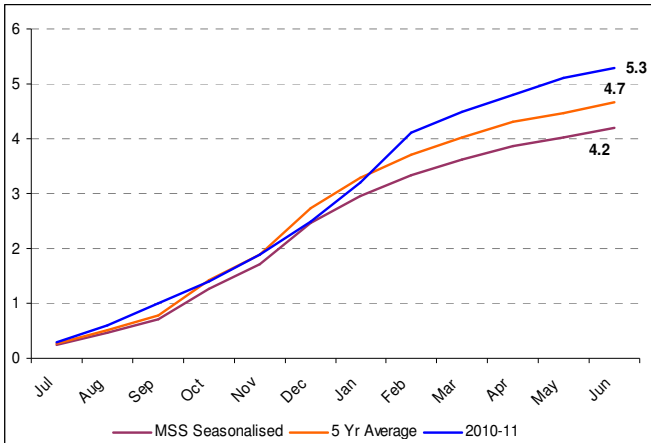
As with the previous SAIDI graphs, Graphs 12 to 15 indicate the accumulated SAIFI minutes from 2010-11 along with the previous 5 year average (2005-06 to 2009-10) and the 'seasonalised' target value.

Many of the issues discussed previously contributed to the increased SAIFI in 2010-11. The most significant outages contributing to the Darwin system SAIFI in 2010-11 were caused by storms affecting the 66kV network connected to the Palmerston Zone Substation and also outages during the commissioning of new equipment at Casuarina Zone Substation.

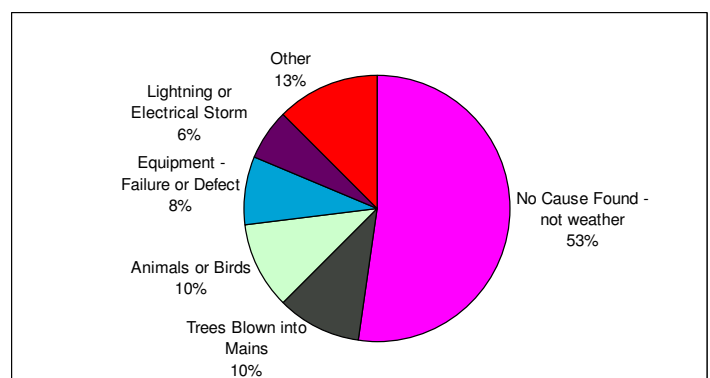
Graph 77: 22MM13 Dundee: > 2500 Minutes

Graph 78: 22MM13 Dundee: > 27 Interruptions

22MM13 Dundee is a long feeder in the rural area and most outages in 2010-11 were due to weather and storm related events, including 6,892 minutes contributed during two days of Cyclone Carlos. A feeder upgrade has been planned for this feeder in 2011-12, including the installation of new Gas Break Switches (GBS) and GCR as well as the relocation of existing GBS and GCR, which will improve sectionalising and reduce the impact of outages.
