Standards of Service 2009-10

Key Service Performance Indicators

Revised February 2011

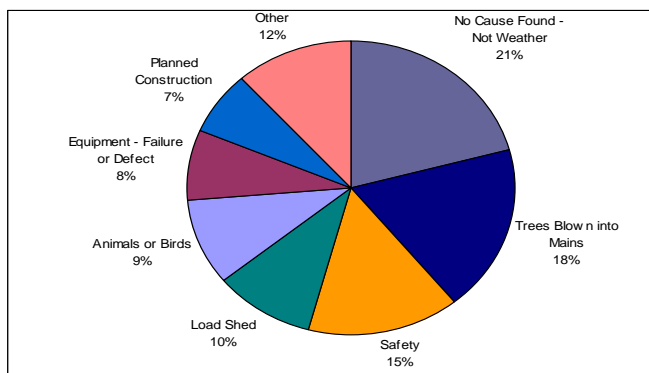
Graph 1 illustrates the main causes of outages that contributed to SAIDI in Alice Springs.

Graph 1: Alice Springs SAIDI – Cause Descriptions

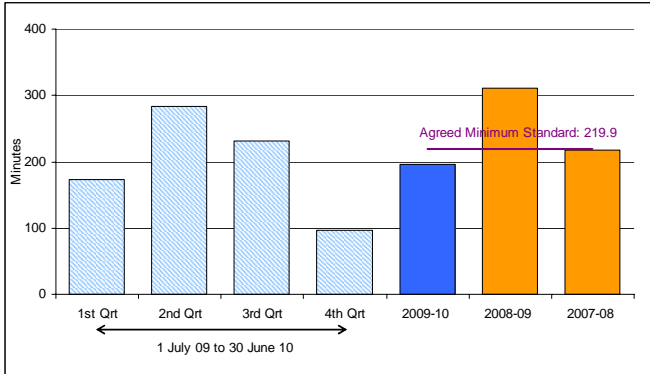
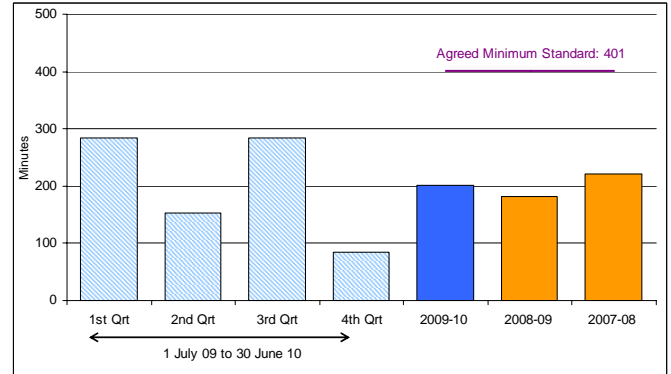
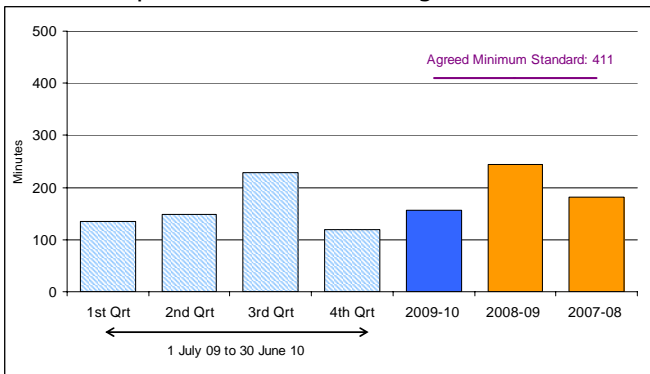
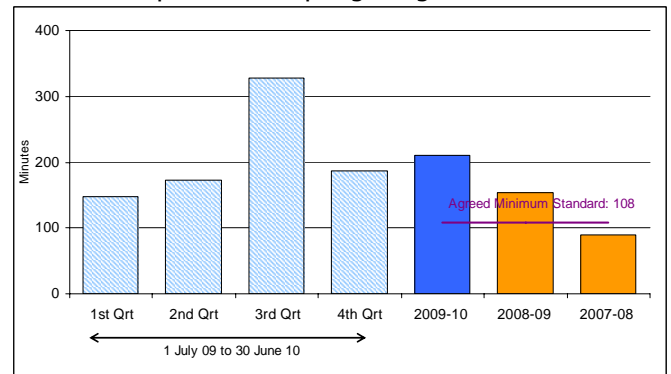
Graphs 2 to 5 show Power and Water’s quarterly and yearly actual regional performance for the adjusted SAIDI service performance indicator for Power Networks.

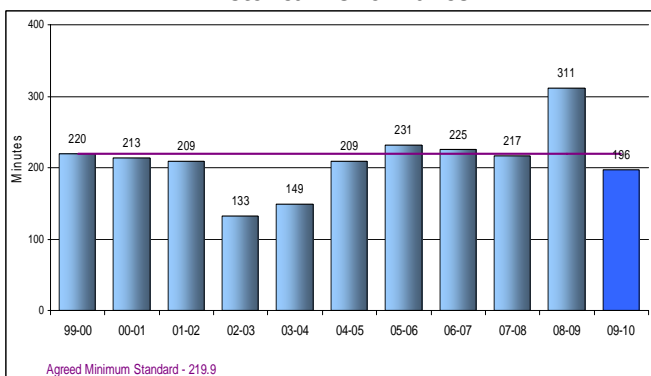
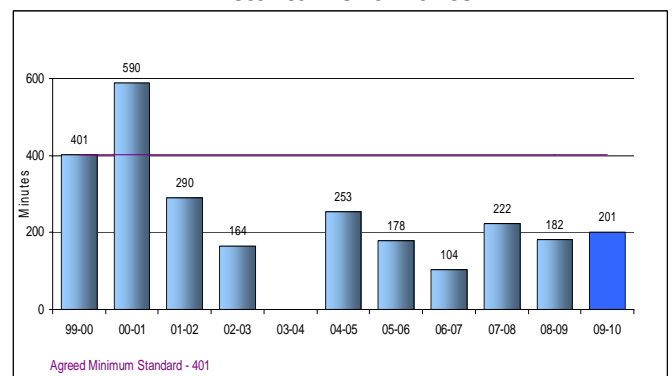
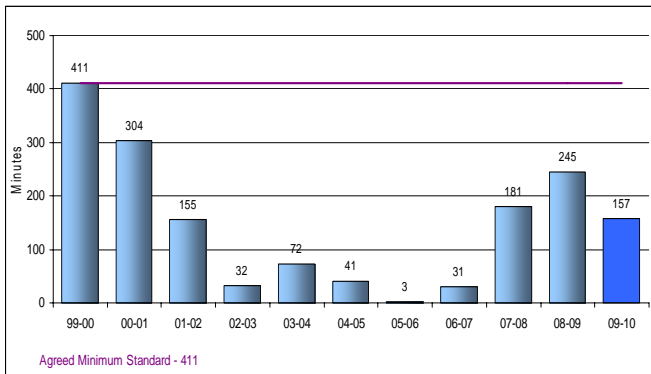
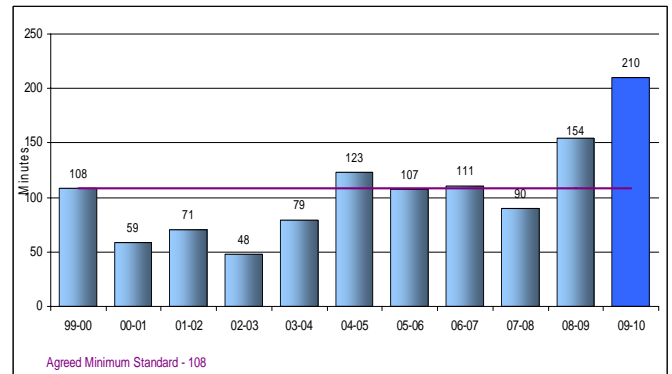
Graphs 6 to 9 show Power and Water’s regional historical performance for the adjusted SAIDI service performance indicator for Power Networks.

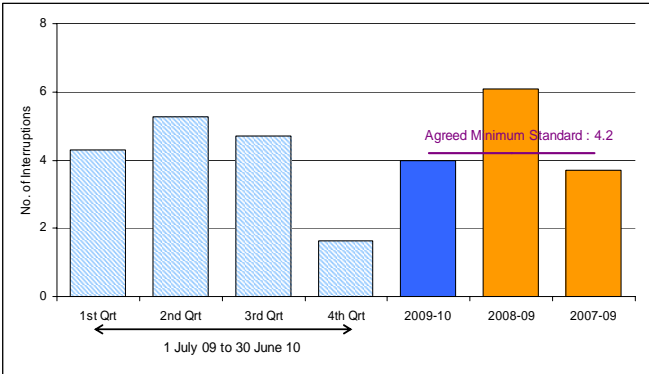
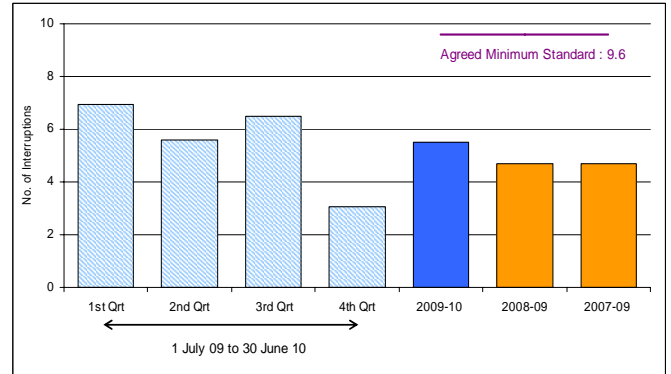
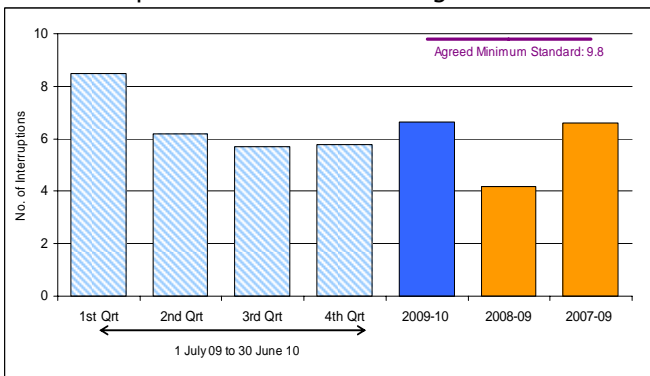
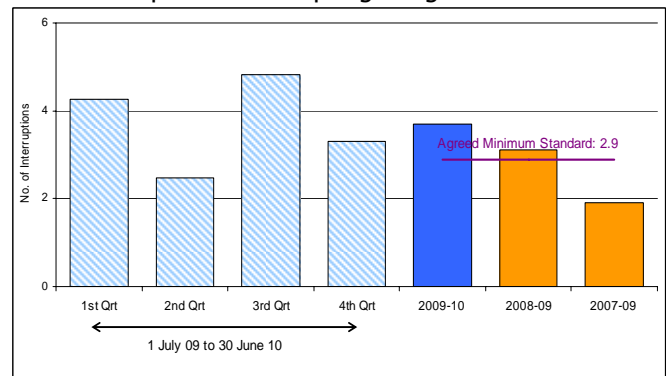
Graphs 10 to 13 show Power and Water’s actual performance for the adjusted SAIFI reliability standards indicator for Power Networks on a quarterly and annual basis for each region.

Alice Springs’ interruption frequency was above the minimum standard. The three most significant outages contributing to the Alice Springs system SAIFI in 2009-10 were under frequency load shed, a bird strike on an overhead conductor and an 11kV feeder outage with no cause found.

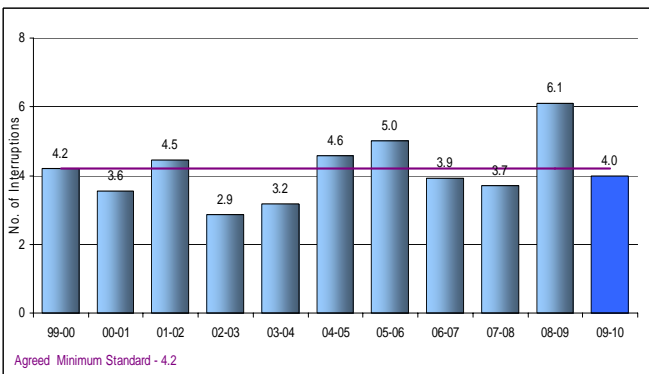
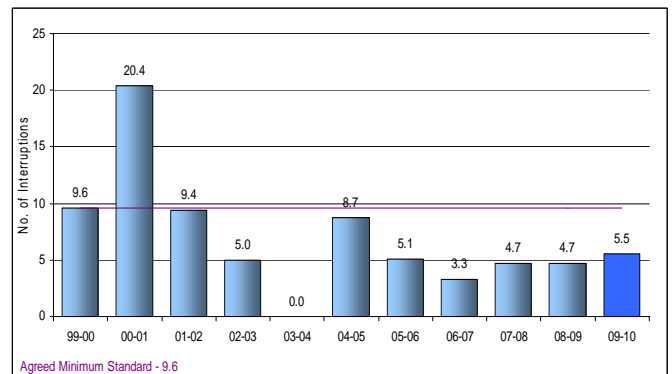
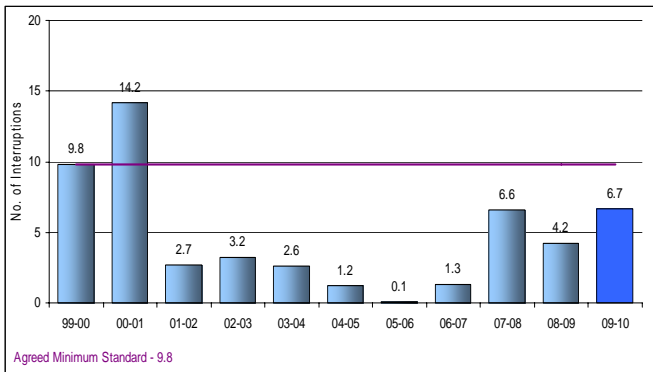
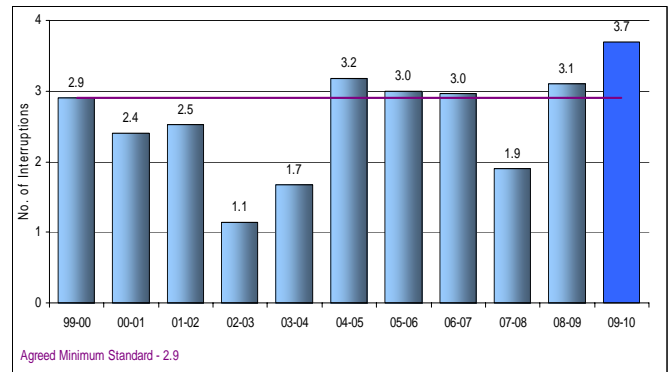
Graphs 14 to 17 show Power and Water’s historical performance for the adjusted SAIFI service performance indicator for Power Networks on an annual basis for each region.

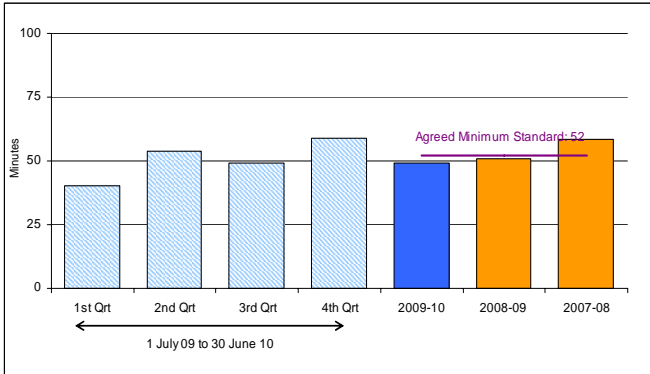
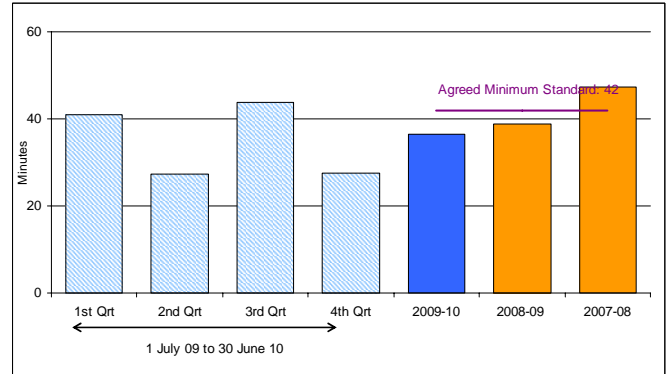
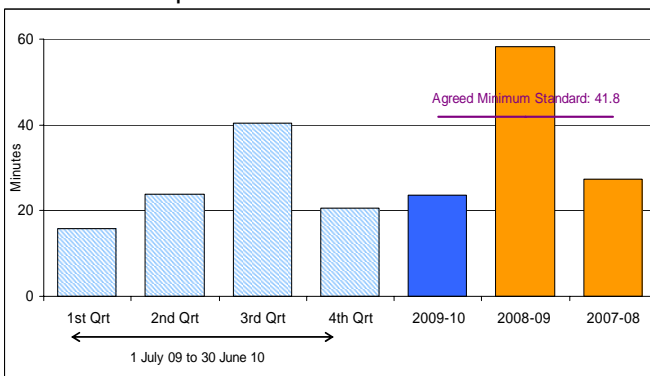
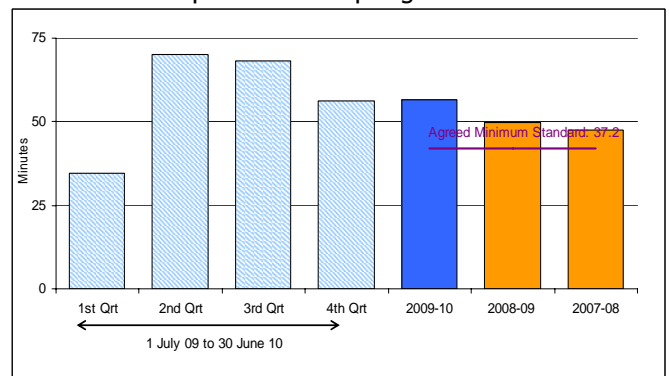
Graphs 18 to 21 show actual performance for the adjusted CAIDI service performance indicator for Power Networks on a quarterly and annual basis for each region.

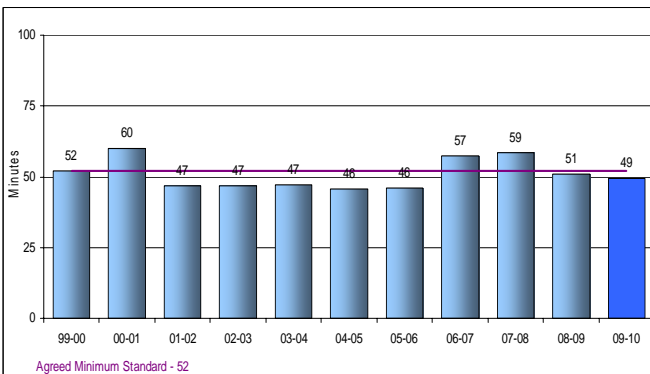
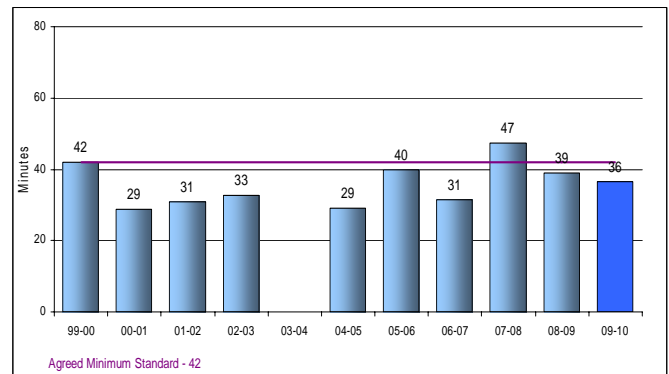
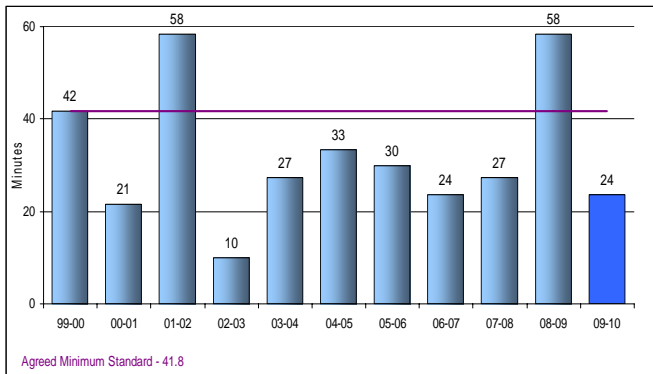
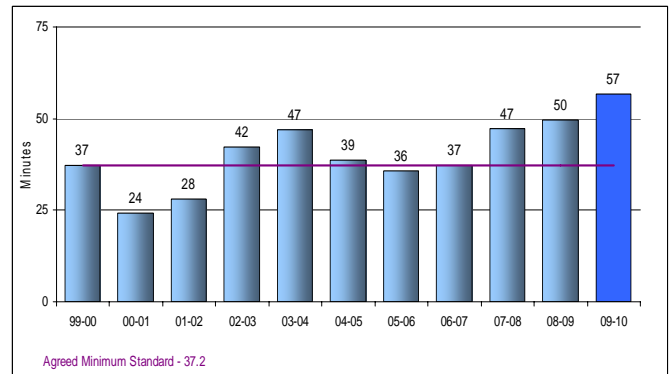
Graphs 22 to 25 show Power and Water’s historical performance for the adjusted CAIDI service performance indicator for Power Networks on an annual basis for each region.

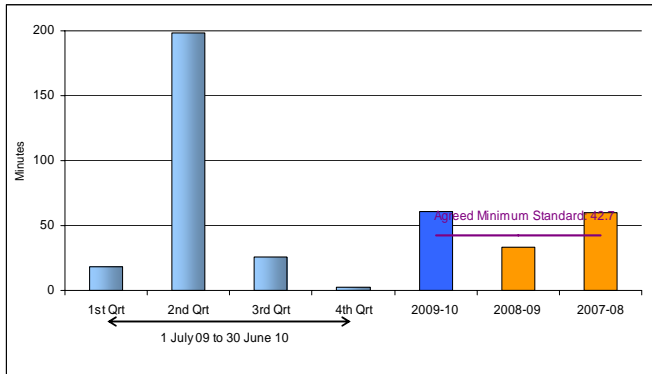
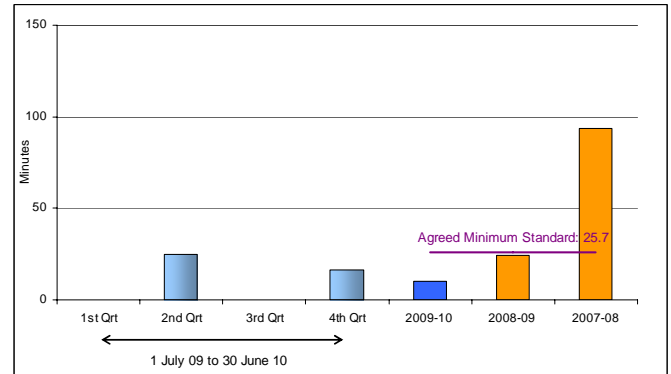
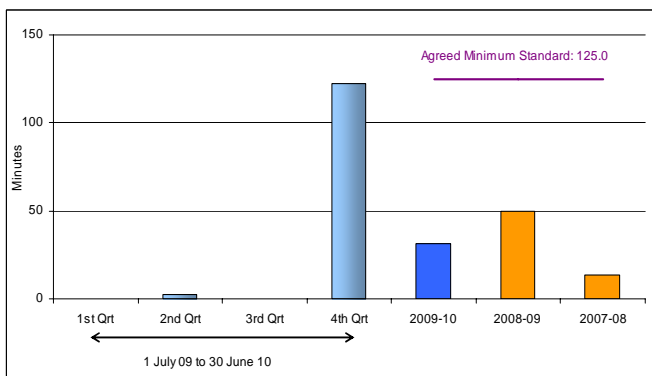
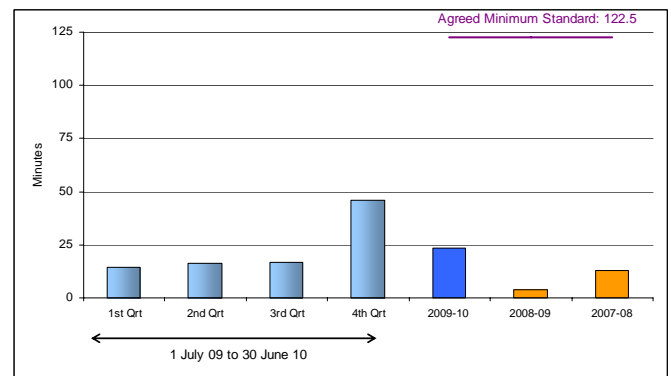
Graphs 26 to 29 show Power and Water’s actual performance for the SAIDI service performance indicator for Generation on a quarterly and annual basis for each region.

The annual performances for SAIDI in the Katherine, Tennant Creek and Alice Springs regions were within the agreed minimum standards. The annual performance for SAIDI in the Darwin region did not meet the agreed minimum standard.

The major cause for exceeding the SAIDI target in the Darwin region was the result of an interruption in gas supply at the Weddell Power Station (WPS). This caused a loss of power to approximately 14,000 customers in the northern suburbs, Palmerston and Katherine. The cause of this interruption was due to the presence of a slug of diesel that had entered the filter/coalescers at the Weddell Metering Station. When this was discovered, NT Gas prudently shut-off gas supply to prevent further damage. Subsequent investigations by Power and Water and APA Group concluded that a slug of diesel from the Bonaparte Gas Pipeline corrosion inhibition program was released and gradually made its way along the Amadeus Basin to Darwin Pipeline, finally entering the Wickham Point Interconnect and the gas delivery system at WPS. It is clear that the liquid collection facility (a large slug catcher) installed at Ban Ban Springs by APA Group was not effective in collecting liquids from the Bonaparte Gas Pipeline as it was designed to.

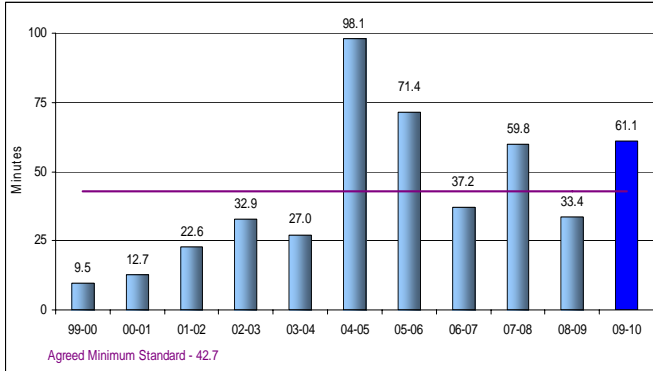
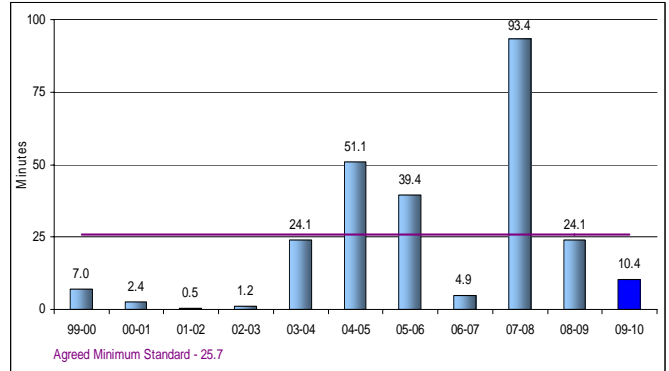
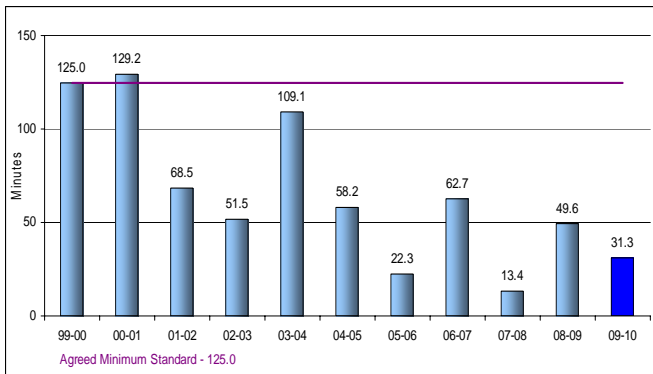
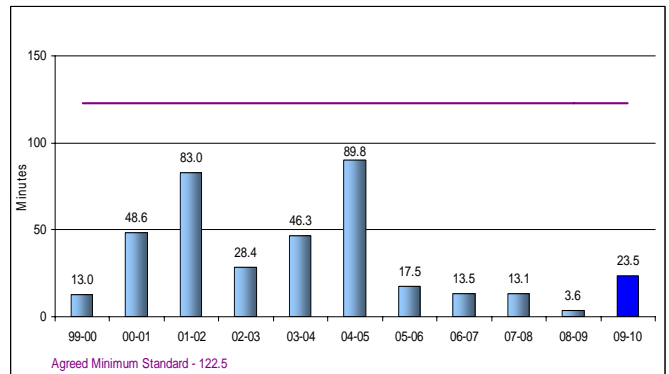
Graphs 30 to 33 show Power and Water’s historical performance for the SAIDI service performance indicator for Generation on an annual basis for each region.

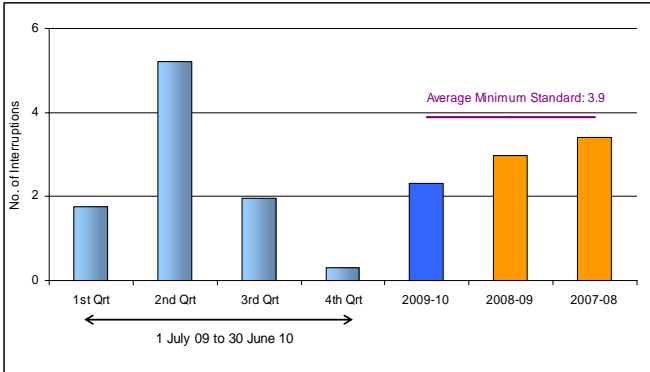
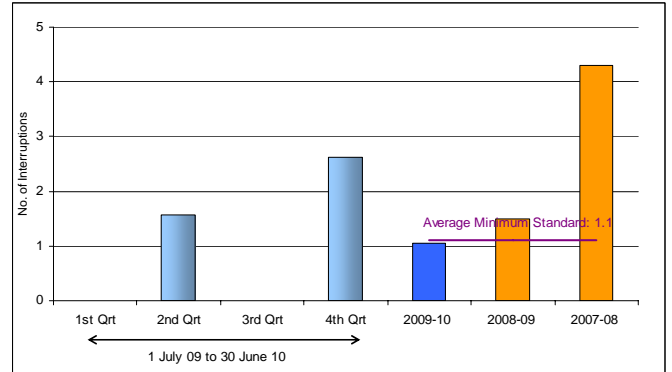
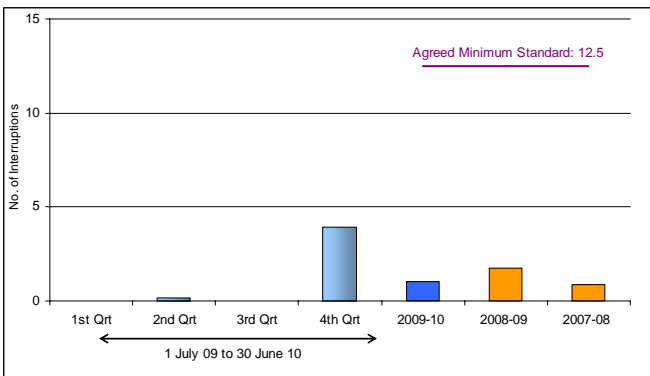
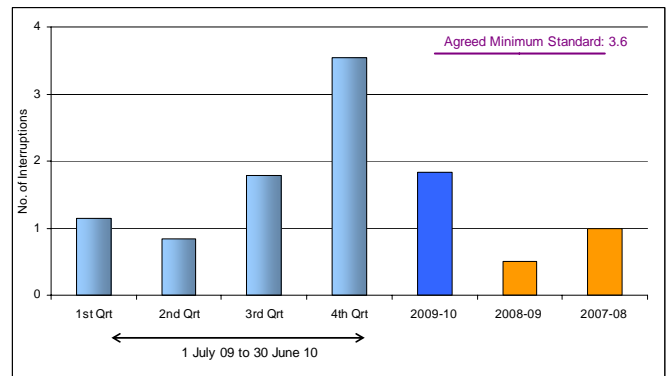
Graphs 34 to 37 show Power and Water's Generation SAIFI performance on a quarterly and annual basis.

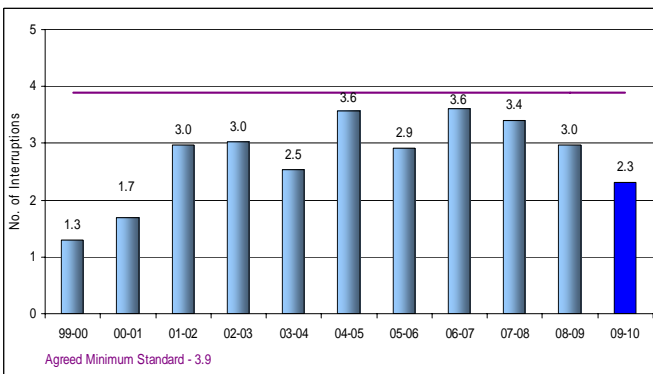
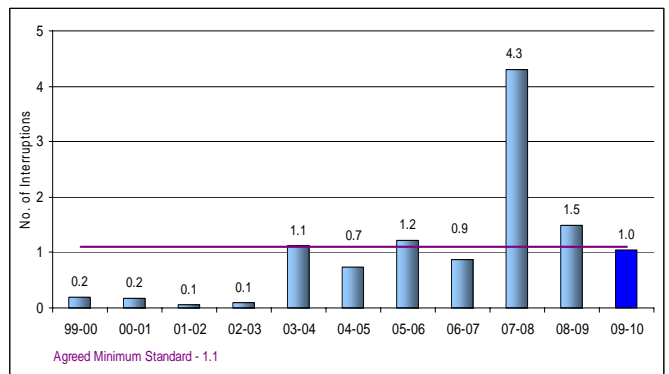
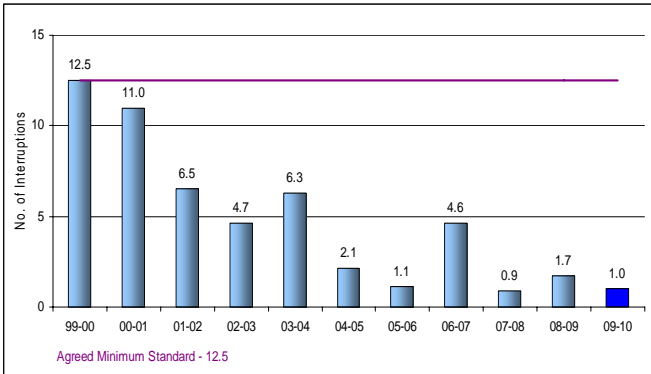
Graphs 38 to 41 show Power and Water's historical Generation SAIFI performance.

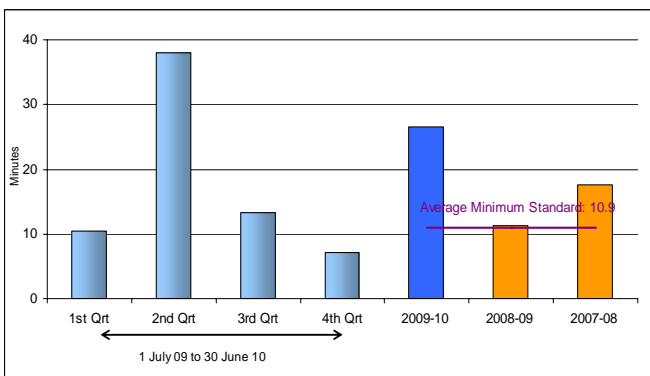
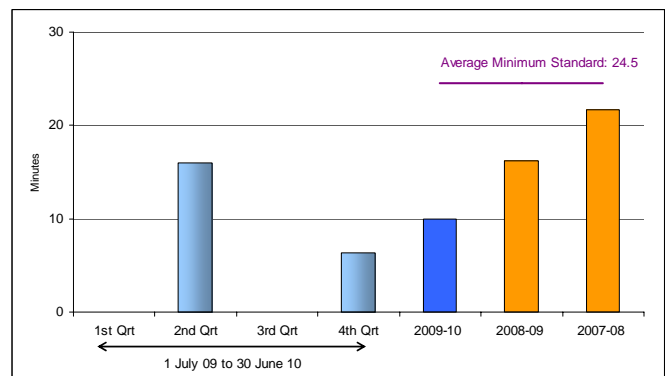
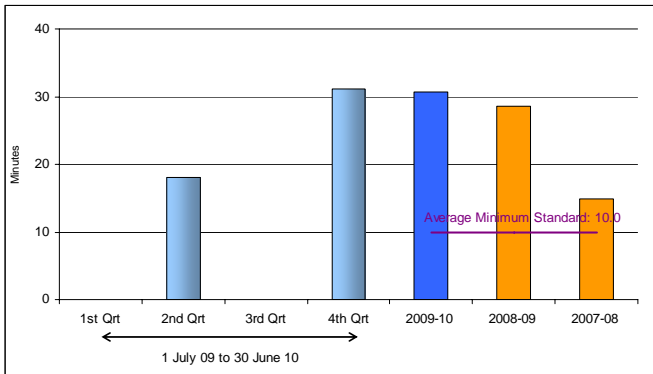
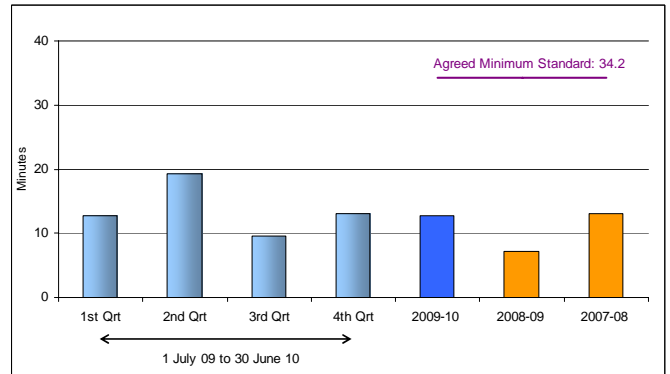
Graphs 42 to 45 show Power and Water's actual performance for the CAIDI service performance indicator for Generation on a quarterly and annual basis for each region.

Generation’s CAIDI performance in the Darwin and Tennant Creek regions exceeded the minimum standard in 2009-10. These were directly related to gas supply issues which affected Power and Water in 2009-10. The Darwin region, whilst experiencing an increase in duration of outages in 2009-10, recorded a decrease in frequency when compared to previous years. The Generation CAIDI issue in Tennant Creek is misleading as the region has recorded a reduction in both SAIDI and SAIFI.

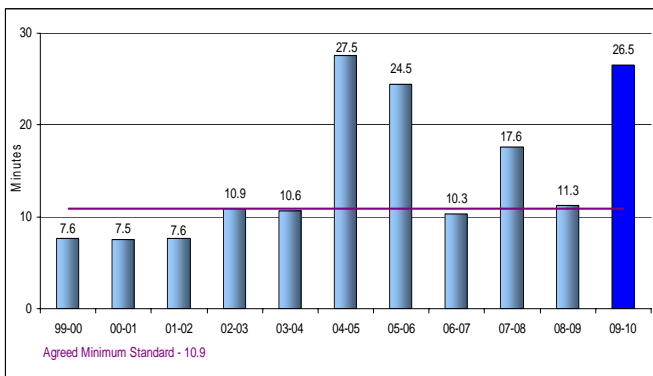
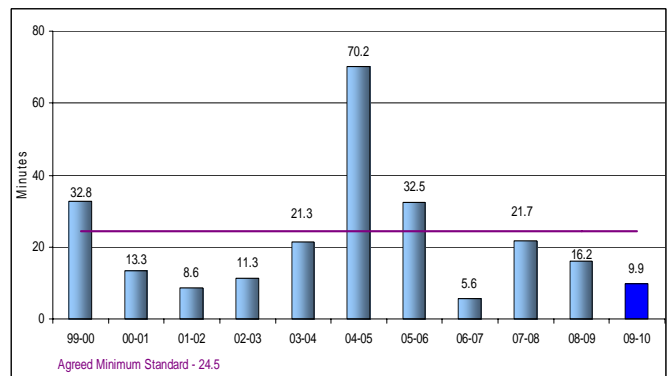
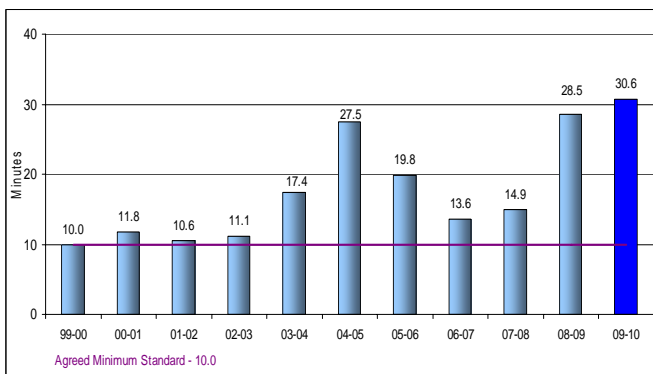
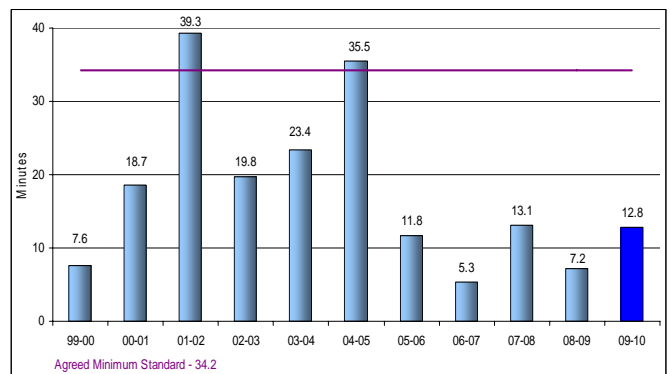
Graphs 46 to 49 show Power and Water’s historical performance for the CAIDI service performance indicator for Generation.

As mentioned previously, Power and Water considers that the CAIDI performance measurement is a flawed indicator for outages, as the calculation is based on duration of outages over outage frequency. This can result in a situation where having a higher frequency of outages benefits the outcome of the performance indicator, which may not reflect improvement in either duration or frequency of outages.

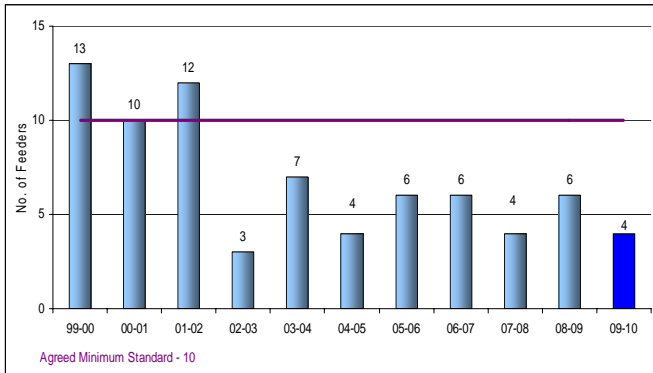
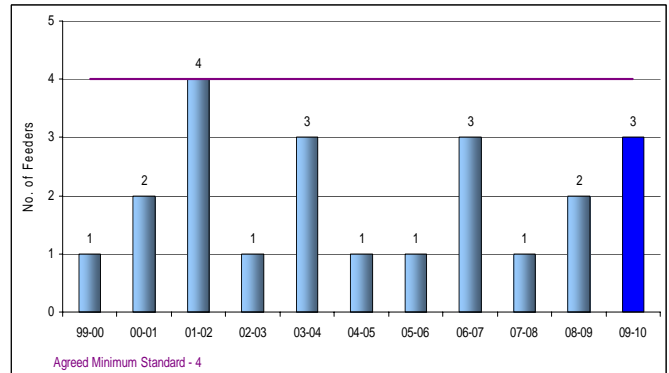
Graphs 50 to 51 show Power and Water’s historical performance for the number of feeders that experience more than 15 interruptions per year on interconnected distribution networks in the Darwin-Urban and Alice Springs region.

The feeders that experienced more than 15 interruptions in the Darwin-Urban region were 11BE13 Kormilda, 11CA13 Wanguri, 11CA23 Moil and 11SN01 Fannie Bay. The 11BE13 Kormilda feeder was also a poorly performing feeder in 2008-09.

The feeders that experienced more than 15 interruptions in the Alice Springs region were 22RG13 Brewer 1, 22RG04 Brewer 2 and 22RG09 Farms. The 22RG13 Brewer 1 and 22RG04 Brewer 2 feeders were also poorly performing feeders in 2008-09.

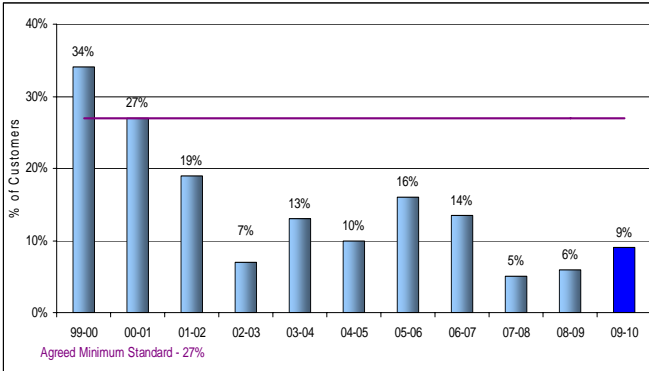
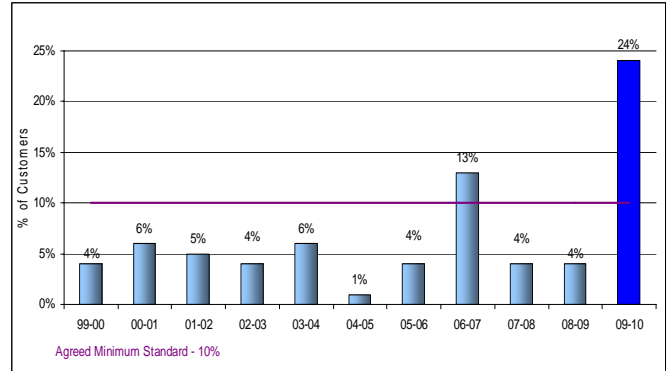
Graphs 52 to 53 show Power and Water’s historical performance for the percentage of customers supplied by feeders that experience more than 15 interruptions per year on interconnected distribution networks for the Darwin-Urban and Alice Springs regions.

Power and Water met the agreed minimum standard in the Darwin-Urban region but did not achieve the standard for this indicator in the Alice Springs region. The three most significant outages for Alice Springs resulted from an under frequency load shed, a bird strike on an overhead conductor and an 11kV feeder outage with no cause found.

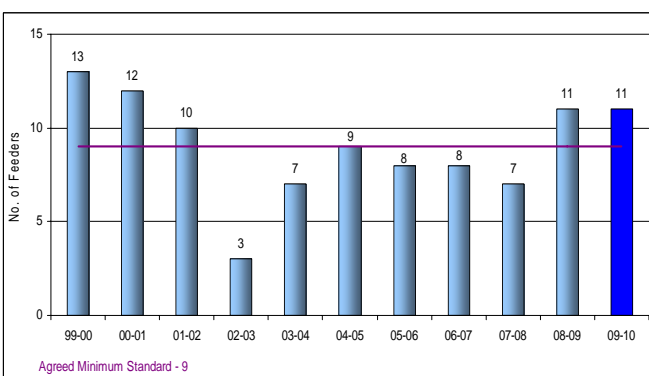
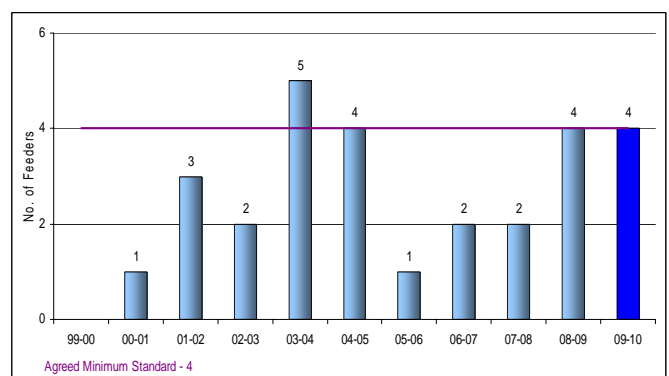
Graphs 54 to 55 show Power and Water’s historical performance for the number of feeders that experience more than 1,500 minutes of interruptions per year on interconnected distribution networks for the Darwin-Urban and Alice Springs regions.

Power and Water did not achieve the standard for this indicator in the Darwin-Urban region, and was in-line with the standard in Alice Springs. The three most significant outages for Darwin-Urban resulted from an under frequency load shed caused by lightning and electrical storms on 30 January 2010.

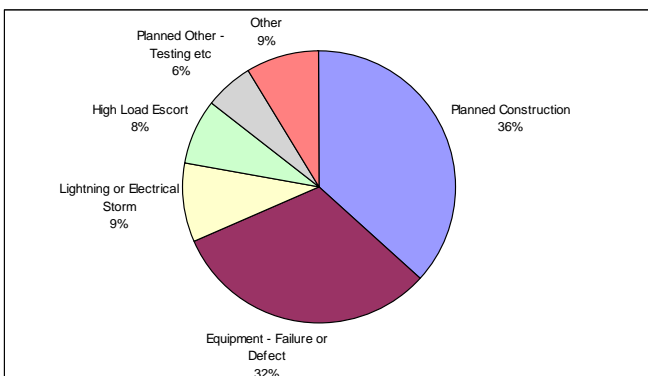
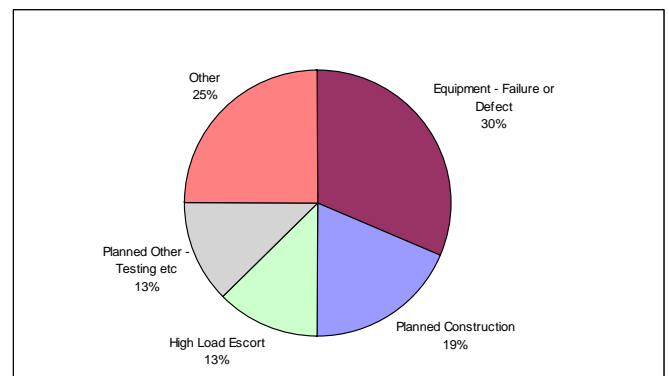
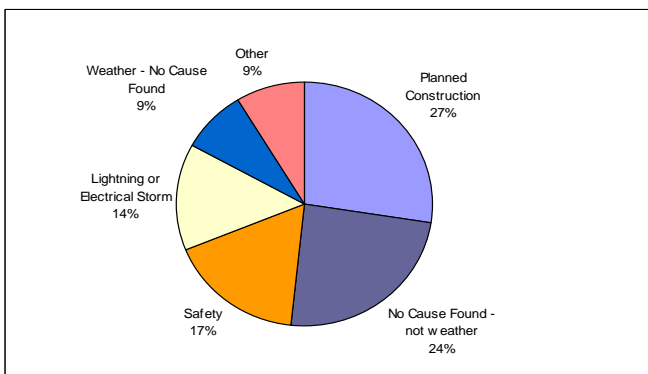
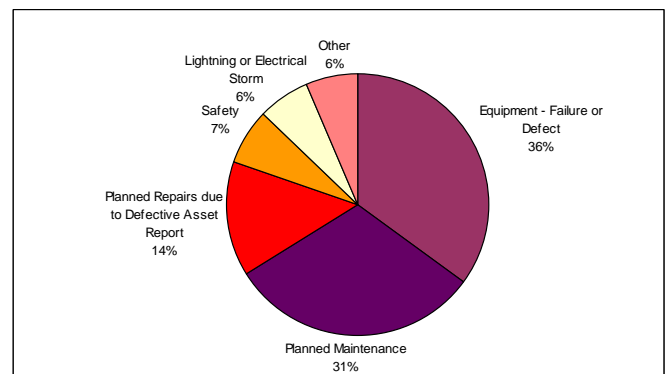
Of the outages reported in 2009-10 in the Darwin-Urban region, three feeders were also poor performing in 2008-09 (highlighted in bold type in the above table). Graphs 56 to 59 illustrate the main causes of outages that contributed to these poorly performing feeders in the Darwin-Urban region.

Work on the 11BE13 Kormilda feeder in the last financial year to improve reliability included the upgrading of an air break switch to a more reliable gas break switch and the reconfiguration of the HV network to accommodate road works and high loads on Berrimah road. The substation connected to the 11CA13 Wanguri feeder had been identified as a priority for replacement and was replaced in 2009-10, which will contribute to improved reliability in the future. Reliability works on the 11BE06 Karama feeder in 2009-10 included the general maintenance and replacement of distribution transformers.

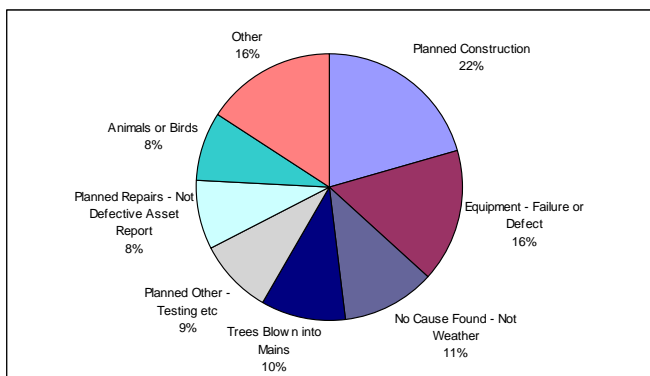
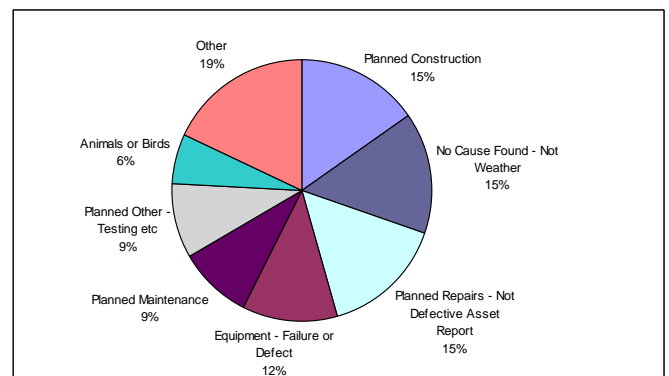
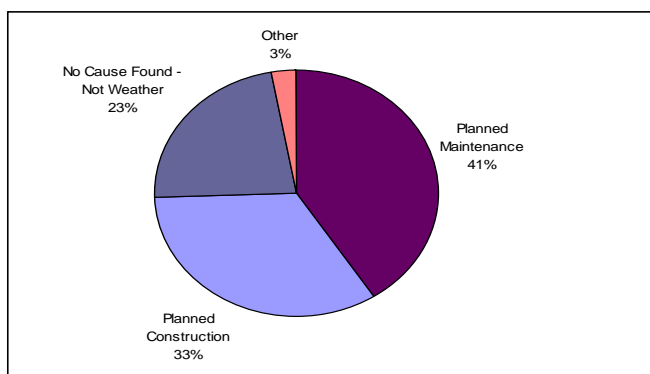
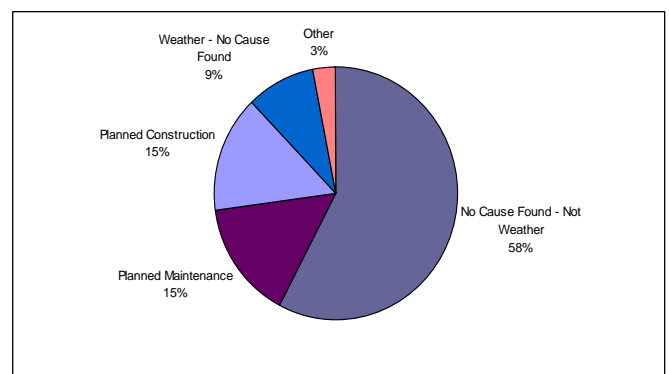
In the Alice Springs region, two Brewer feeders have continued to perform below the standard (highlighted in bold type in the above table). However, the performance of these feeders has improved from the previous year. Graphs 60 to 63 illustrate the main causes of outages that contributed to these poorly performing feeders in the Alice Springs region.

Work on the 22RG13 Brewer 1 feeder to improve reliability included the installation of fuses and cross arms as part of planned maintenance and repairs. Reliability works on the

22RG04 Brewer 2 feeder in 2009-10 included the installation of bird protection and the changing over of HV crossarms from steel to fibreglass.

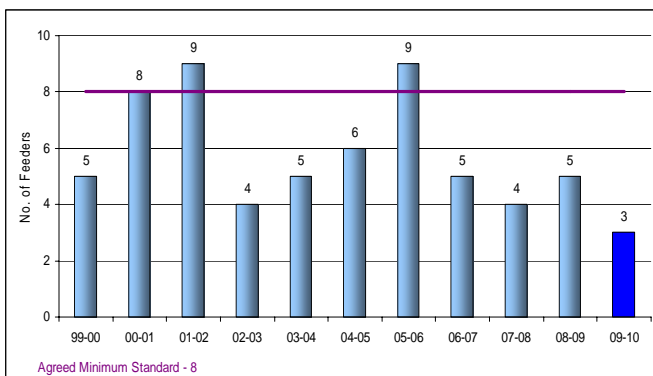
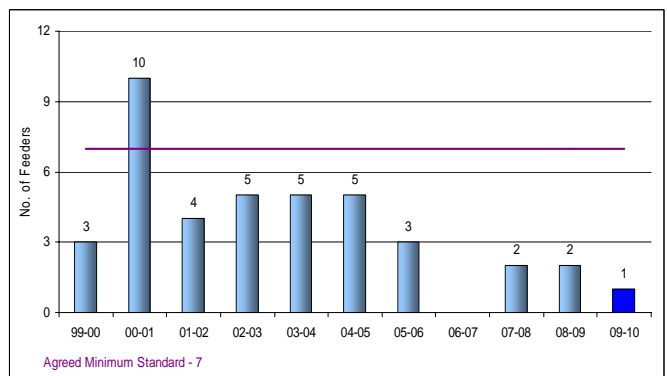
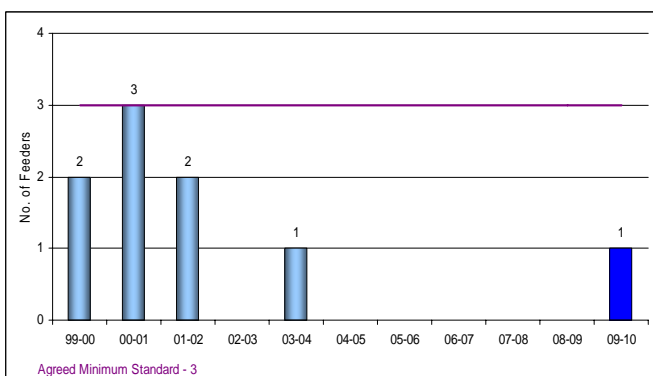
Graphs 64 to 66 show Power and Water's historical performance for this indicator for the Darwin-Rural, Katherine and Tennant Creek regions.

The feeders that experienced more than 27 interruptions in the Darwin-Rural region were 22HD402 Lambells, 22MA07 Acacia and 22MM13 Dundee. The 22MA07 Acacia feeder was also a poorly performing feeder in 2008-09.

The feeder that experienced more than 27 interruptions in the Katherine region was 22PK07 Mataranka. The 22PK07 Mataranka feeder was also a poorly performing feeder in 2008-09.

The feeder that experienced more than 27 interruptions in the Tennant Creek region was the 22TC202 Feeder 2.

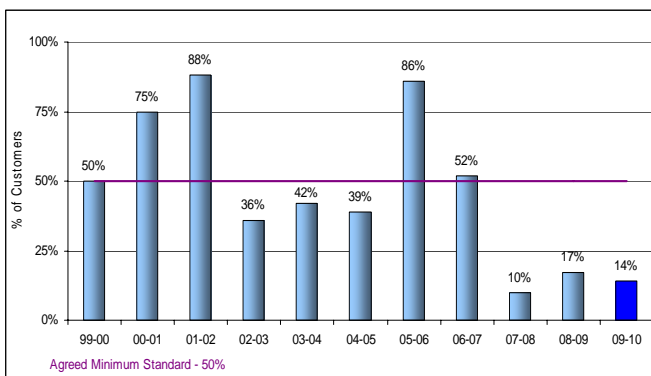
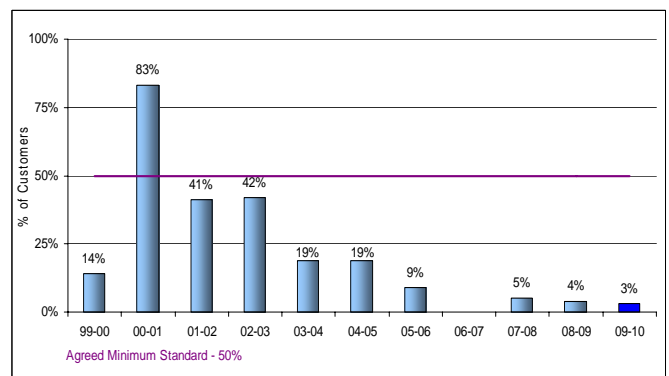
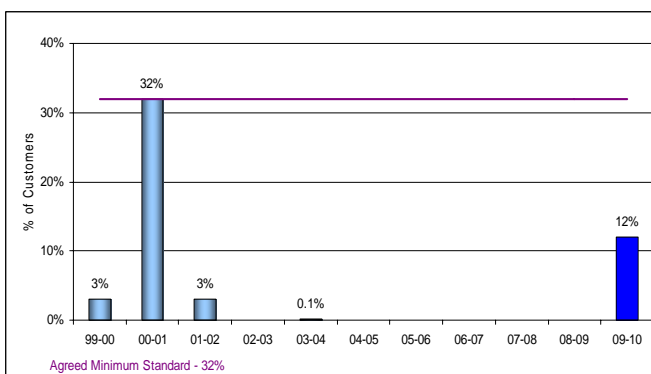
Graphs 67 to 69 show Power and Water's historical performance for this indicator for the Darwin-Rural, Katherine and Tennant Creek regions.

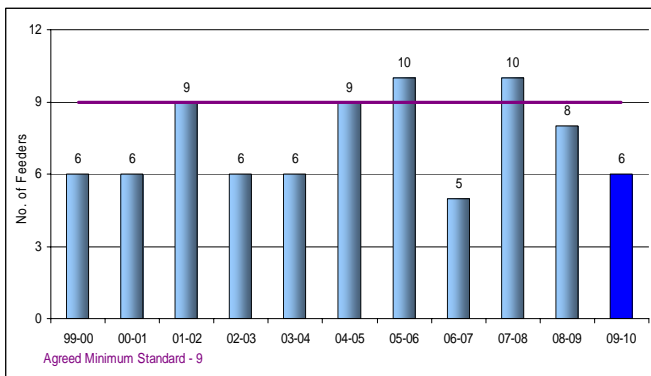
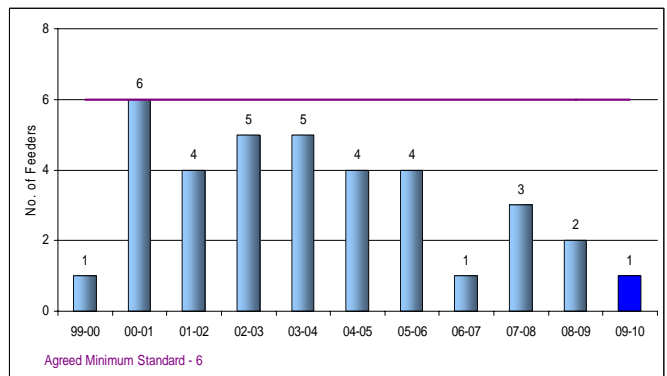
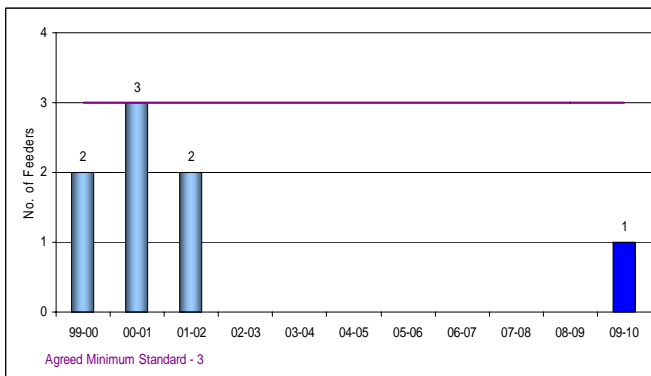
Graphs 70 to 72 show Power and Water's historical performance against this indicator.

The number of Darwin-Rural and Katherine feeders that experienced more than 2,500 minutes of interruptions in 2009-10 was within the agreed minimum standard by 3 and 5 feeders respectively, and showed improvement on the previous year. The number of Tennant Creek feeders that experienced more than 2,500 minutes of interruptions in 2009-10 was within the agreed minimum standard by 2 feeders.

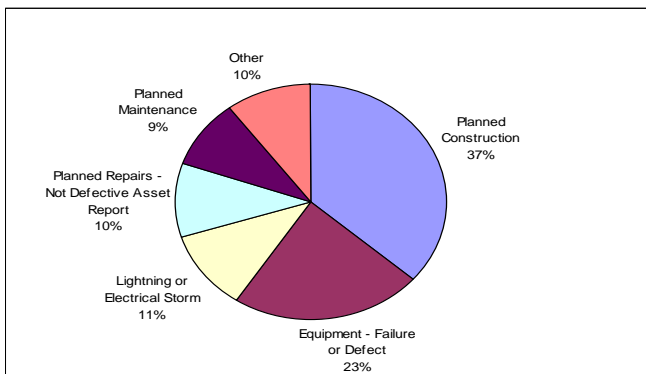
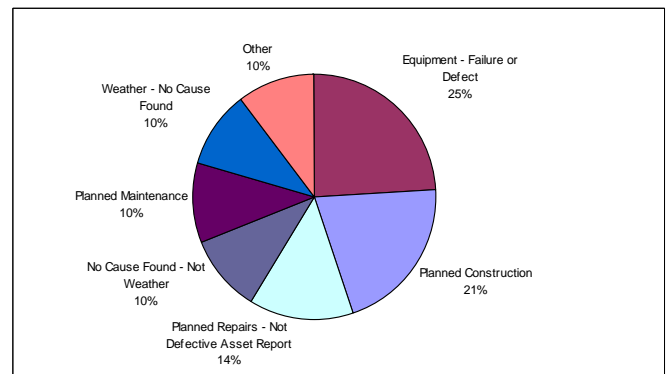
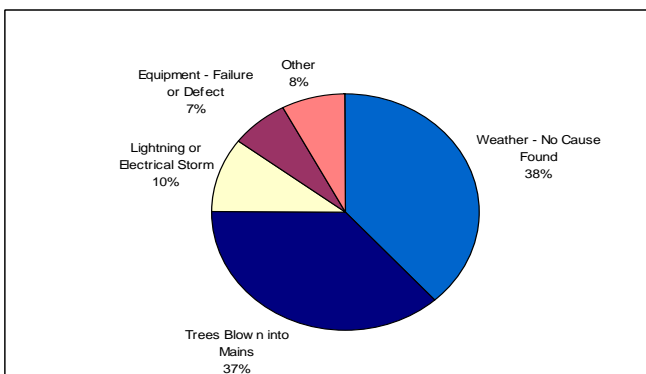
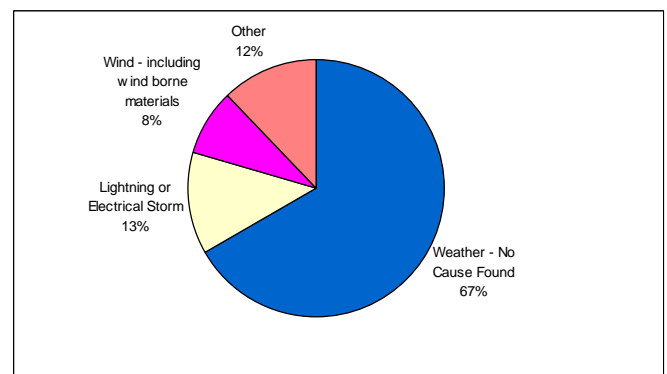
Of the outages reported in 2009-10 in the Darwin-Rural region, three feeders were also poor performing in 2008-09. Graphs 73 to 76 illustrate the main causes of outages that contributed to these poorly performing feeders in the Darwin-Rural region.

Reliability works on the 22MA07 Acacia feeder in 2009-10 included tree trimming and general maintenance and repairs. In 2009-10, approximately 5km of overhead conductor was upgraded on the 22MA03 Adelaide River feeder and work on the 22MR103 Mt Bundy feeder was related to general repairs.

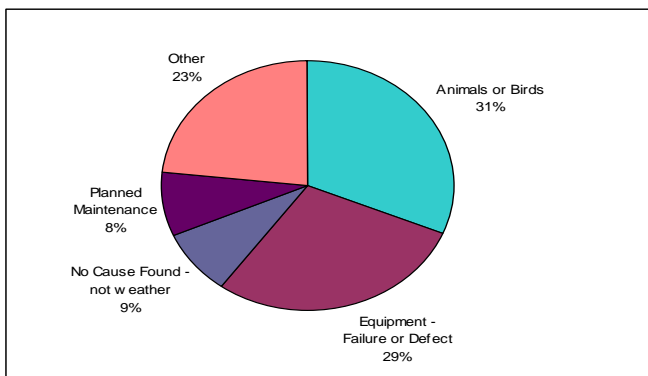
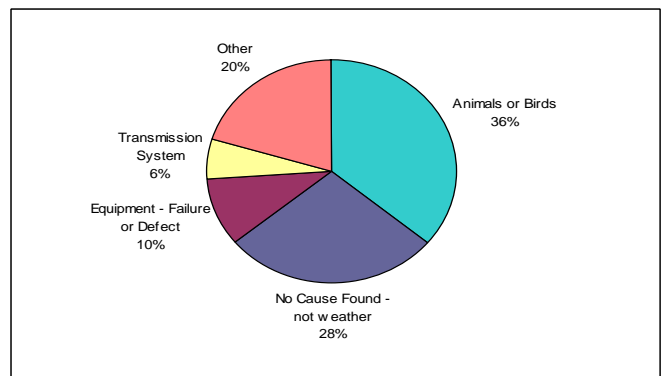
The 22KP07 Mataranka feeder was poorly performing in both 2008-09 and 2009-10. Graphs 77 to 78 illustrate the main causes of outages that contributed to this poorly performing feeder in the Katherine region.

In the last couple of years many of the outages in this area were due to recloses that last for less than half of one second. These are activated as a safety mechanism when tree branches or animals come into contact with the lines. If the cause of the outage clears when power is interrupted, the restoration will occur automatically when the line is re-energised (or reclosed). This points towards bats/animals being the primary problem.

A colony of bats in the Fox Road area south of Katherine caused a number of animal related outages in the second half of 2009. Extensive work has been undertaken to improve reliability in this area. These works include:

- The installation of a gas circuit recloser on Ross Road;
- The replacement of steel overhead transformer fuse arms with insulated overhead transformer fuse arms; and
- The installation of transformer fuse animal guards.

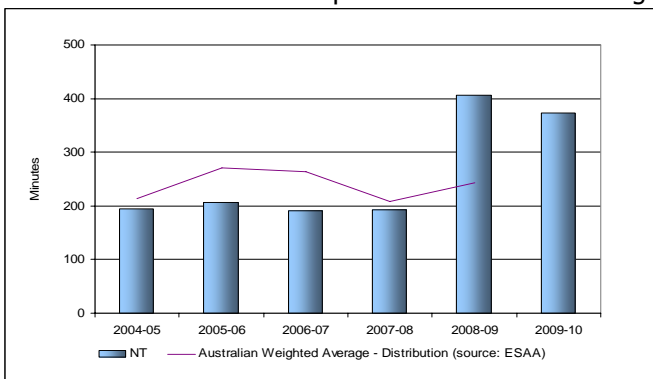
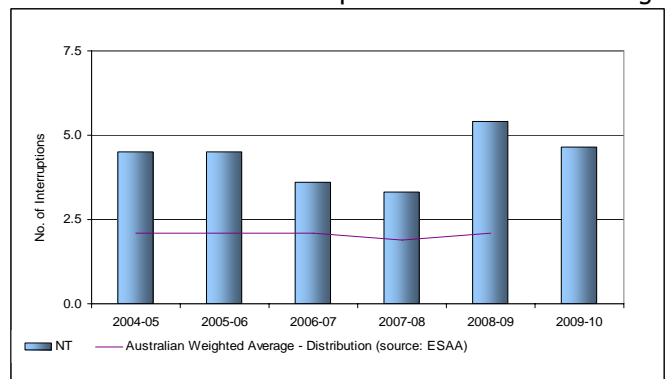
Graphs 79 to 81 compare Power and Water’s historical unadjusted network performance to the Australian weighted average for distribution networks (as published in Energy Supply Association of Australia’s (ESAA) *Electricity Gas Australia* annual publications).

The Northern Territory is a challenging environment in which to maintain reliable power supply. Lightning, storms, fruit bats and vegetation have resulted in the frequency of network outages (SAIFI) over the last six years to 2009-10 being greater than the national average. Despite this, the duration of outages (SAIDI) over the same period has been less than the national average, with the exception of 2008-09 due to the impact of the major and subsequent failures at the Casuarina Zone Substation in September and October 2008, and the major storm in Alice Springs in September 2008. CAIDI is well below the national average, as it is a function of Power and Water’s lower outage duration compared to a higher frequency of outages.
