Standards of Service 2009-10

Key Service Performance Indicators

Revised February 2011

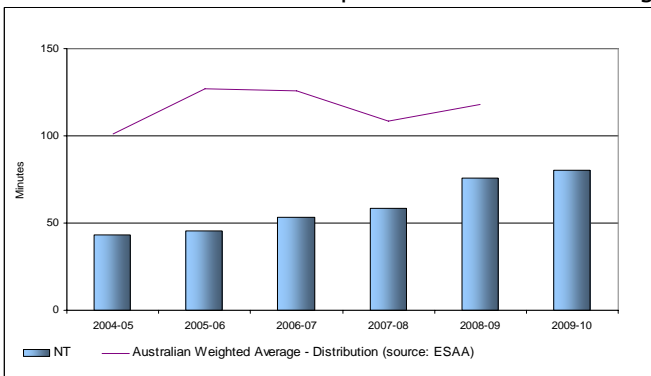
Graph 81: Unadjusted NT CAIDI – Historical Performance compared to Australian Average

Note: ESAA Australian weighted average figures for 2009-10 have not yet been published.

The Northern Territory is a challenging environment in which to maintain reliable power supply. Lightning, storms, fruit bats and vegetation have resulted in the frequency of network outages (SAIFI) over the last six years to 2009-10 being greater than the national average. Despite this, the duration of outages (SAIDI) over the same period has been less than the national average, with the exception of 2008-09 due to the impact of the major and subsequent failures at the Casuarina Zone Substation in September and October 2008, and the major storm in Alice Springs in September 2008. CAIDI is well below the national average, as it is a function of Power and Water’s lower outage duration compared to a higher frequency of outages.

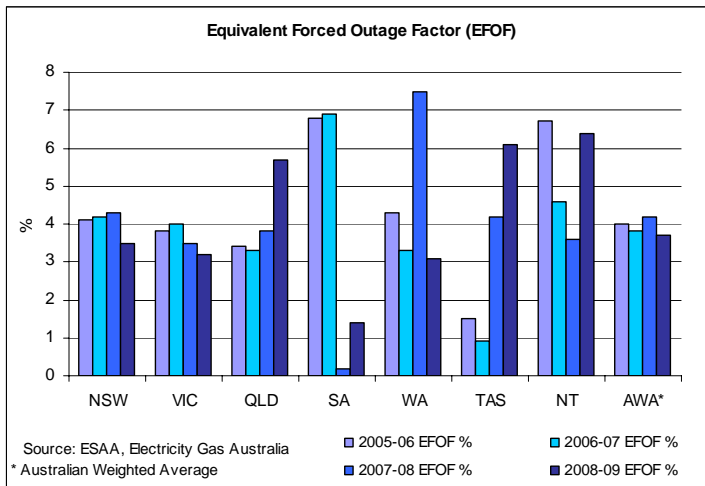
Graph 82: Equivalent Forced Outage Factor (EFOF) - Historical Performance compared to Australian Average

Note: ESAA Australian weighted average figures for 2009-10 have not yet been published.

Outages on the combined cycle block (sets 4, 5 and 6) resulted in a higher Equivalent Forced Outage Factor (EFOF) than the Australian weighted average in 2008-09.

Graph 82 compares Power and Water’s historical generation performance to interstate generators and to the Australian weighted average (as published in ESAA’s *Electricity Gas Australia* annual publications).
