Northern Territory Power System Performance Review 2019-20

Since 2018, the Utilities Commission of the Northern Territory (Commission) has published an annual Northern Territory Power System Performance Review (NTPSPR), which focuses on generation and network performance of the regulated power systems (an electricity network where network access legislation applies), being the Darwin-Katherine, Alice Springs and Tennant Creek power systems. Where possible, the NTPSPR compares current performance to historical data to identify trends.

The 2019-20 NTPSPR is prepared in accordance with section 45 of the *Electricity Reform Act 2000* and is restricted to the Northern Territory's regulated power systems.

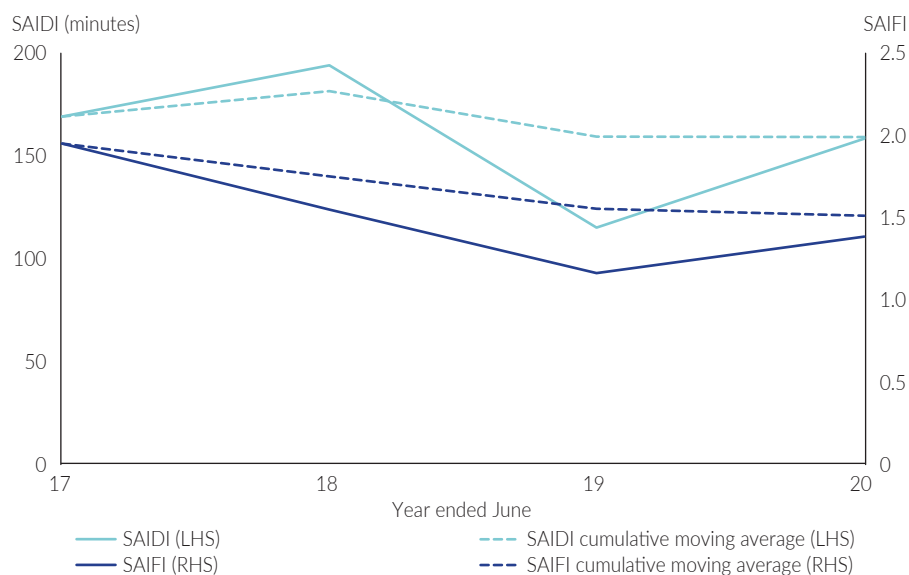
Figure 2: Overall SAIDI and SAIFI performance indices, Darwin-Katherine region⁵

The 2019-20 reporting period shows an increase in SAIDI and SAIFI from 2018-19. Based on the cumulative moving average, SAIDI is trending slightly upwards while the SAIFI remains flat.

The SAIDI and SAIFI indices for the combined Darwin-Katherine region are shown in Figure 2.

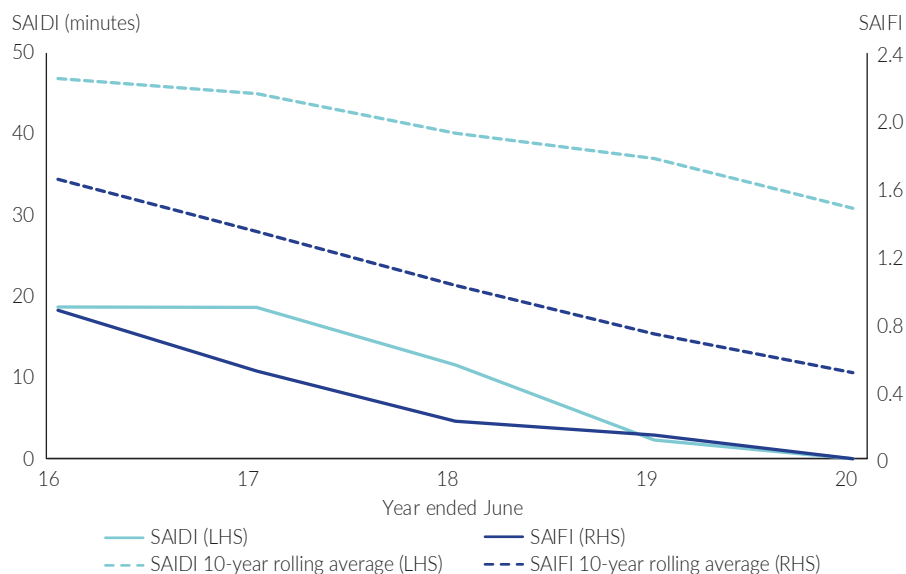
Figure 5: SAIDI and SAIFI performance for generation, Darwin

The trend for these indices continues to improve. That is, the generation fleet is performing well relative to the 10-year average. In 2019-20, Territory Generation reported a SAIDI and SAIFI of zero in the Darwin region, giving an ideal result. The majority of this improvement can be attributed to the reduction in customer interruptions due to single unit trips, which has been achieved in part by changes to spinning reserve. While the number of single unit trips has increased from the previous year, this did not lead to any UFLS events. Therefore, while the robustness of the generating units themselves is not improving, the impact of that robustness, or lack thereof, is not being felt by customers. The high number of single generator unit trips is discussed in the following section.

The generation service level for the Darwin region is shown using the SAIDI and SAIFI performance (see Figure 5).

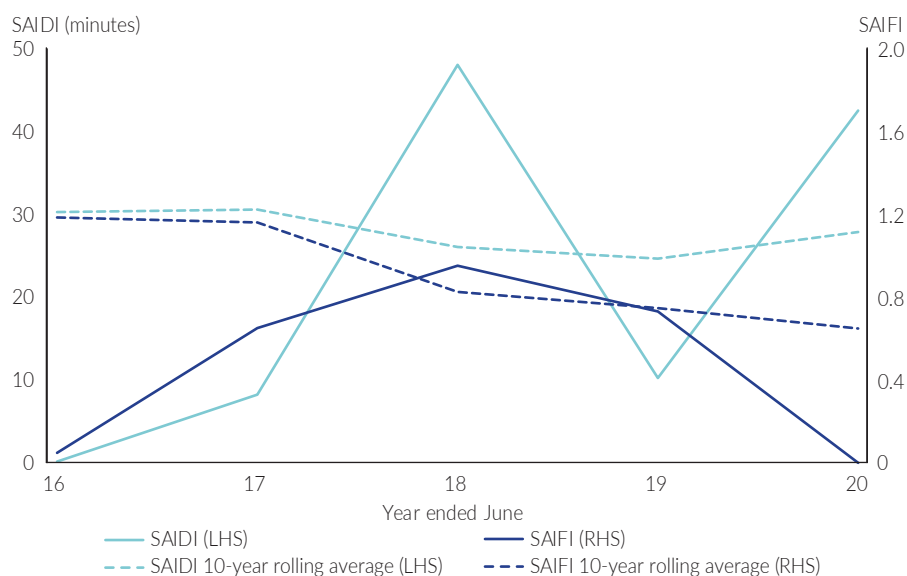
Figure 6: SAIDI and SAIFI performance for generation, Katherine

SAIDI shows a significant deterioration from 2018-19. SAIDI has increased to levels comparable to the performance of the 2017-18 period, which is the worst performing year in the last five years, and is above the 10-year average by a substantial level. SAIFI continues to trend downwards with a significant improvement from 2018-19, with a recorded index of zero. A recorded SAIFI of zero is possible if incidents were not initiated by generation but generation caused the outage period to be extended mainly due to failure of units during restoration. This seems to be the case for the Katherine region.

SAIDI and SAIFI are compiled for the generating units in the Katherine region separately (Figure 6).

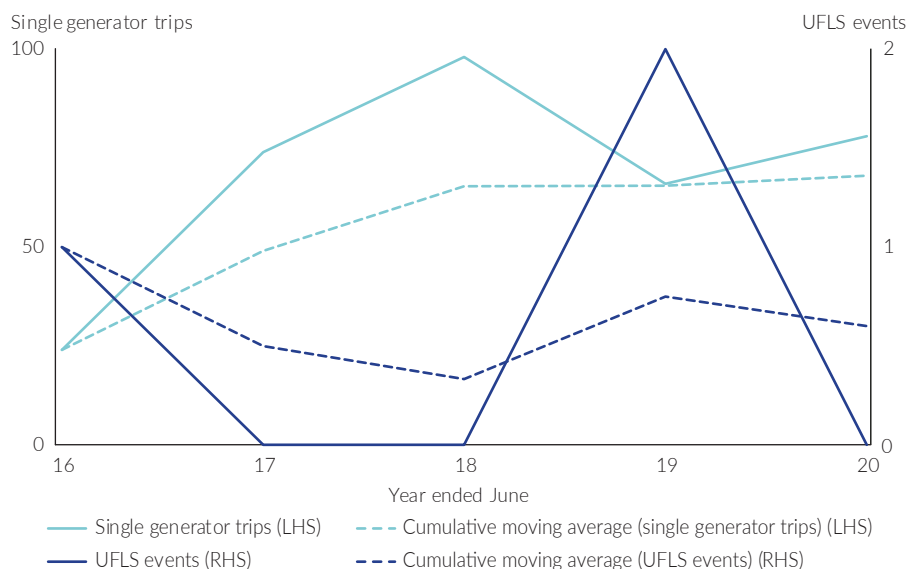
Figure 7: Darwin-Katherine single generator trips versus UFLS (due to single generator trips)

In 2019-20, the number of single unit trips increased compared with 2018-19, however is still lower than a high in 2017-18, and there were no UFLS incidents. Entura considers this to be a good result as it indicates the upward trend in generator trips may be slowing and may indicate an improvement in robustness.

System Control biannual reports¹⁰ to the Commission show a rise in unit trips over the last year, however none caused load shedding (Figure 7).

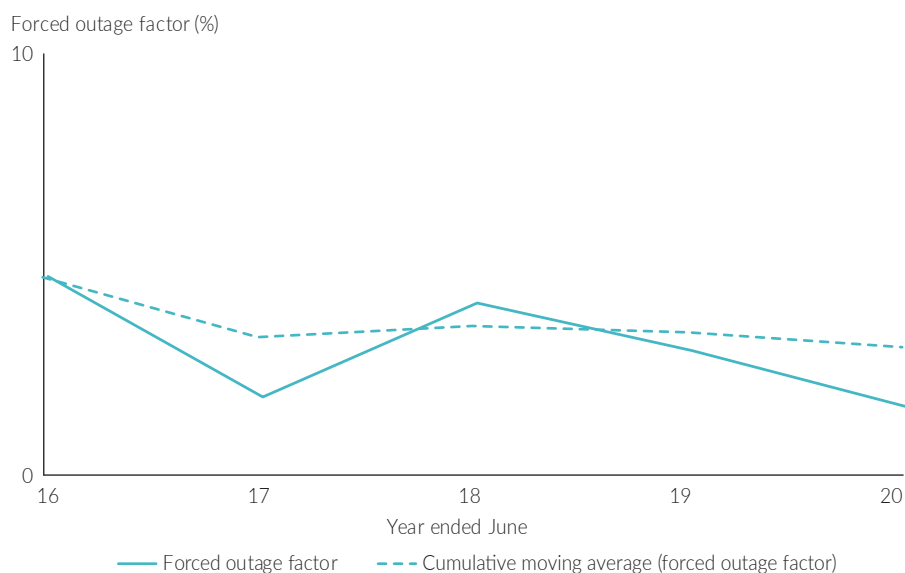
Figure 9: Capacity weighted average forced outage factor for Darwin-Katherine generating units

The performance in 2019-20 is now at the same level as 2016-17, which was the best performing year in the last five years, and below the cumulative moving average. Improvements in performance at the Pine Creek and Weddell power stations, in terms of forced outages, contributed to a better overall result. The 2019-20 result continues the encouraging downward trend in forced outage factor.

Figure 9 shows the capacity weighted average forced outage factor for the Darwin-Katherine power system over the last five years.

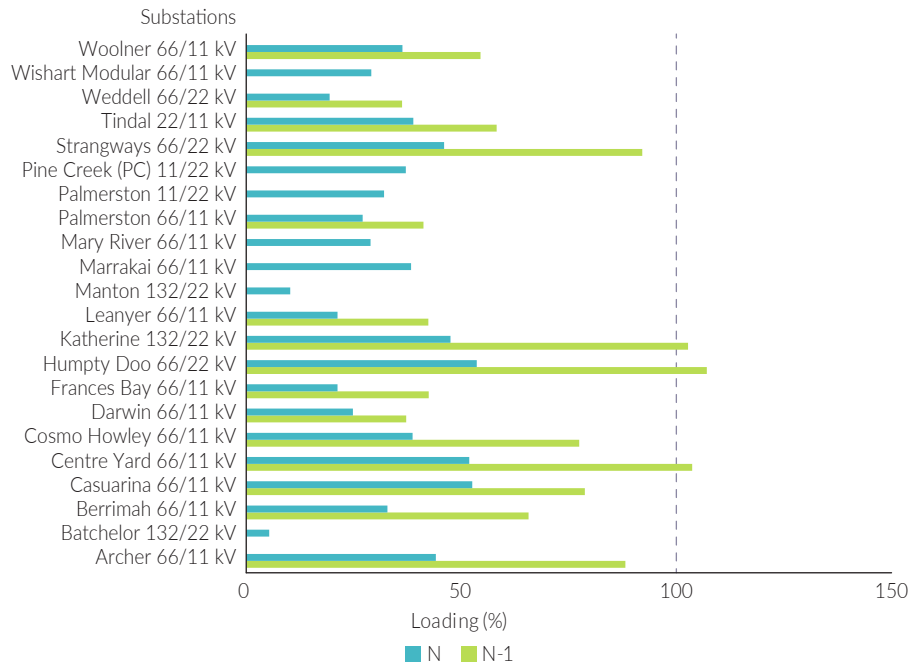
Figure 14: Substation utilisation for N and N-1 conditions Darwin-Katherine

Figure 14 shows actual zone substation loading in 2019-20. On the basis that substation loading, either N or N-1, should not exceed 100%, in 2019-20, Katherine, Humpty Doo and Centre Yard substations were at risk of not fully supplying the substation load had one transformer gone out of service (N-1).

The zone substation transformer loading under N and N-1 conditions for 2019-20 is shown in Figure 14. The substations of concern in the figure are those where either the N (single and multiple transformer substations) or N-1 (multiple transformer substations) loading exceeds 100%.

PWC's 2020 TDAPR states that PWC has a generator in place with 1 MW capacity in case of an emergency event at the Centre Yard substation. At the Humpty Doo substation, PWC states it can install a spare transformer in an emergency as load transfers to adjacent zone substations cannot address the N-1 limitation. As for the Katherine substation, PWC is currently exploring options to procure generators that can directly connect to the 22 kV bus at the Katherine substation, which would allow load to be supplied for a short period if an overload event occurs under N-1 conditions.

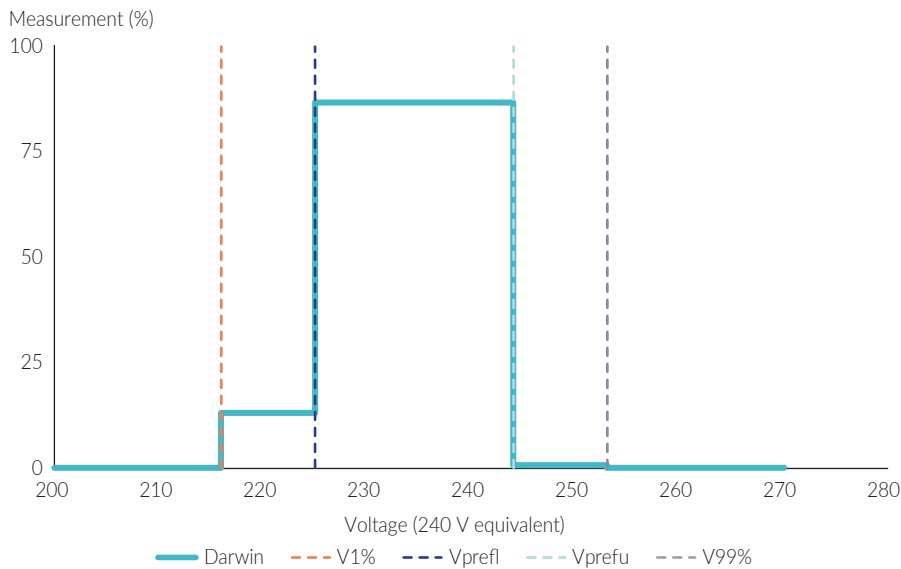
Figure 16: Steady-state voltage performance, Darwin

The measurement and reporting against this criterion is important in modern power systems where voltage can no longer be reliably regulated by the distribution transformer alone. In 2019-20, voltage regulation in Darwin slightly declined where voltage in the preferred zone (that is, between V_{prefl} and V_{prefu}) was around 86% in comparison to 91% in 2018-19. The high voltage periods have reduced while low voltage periods have increased from 7% to 13%. This is contrasted by the Katherine region where Power Services report a lack of buck (voltage reducing) taps on the transformers, in conjunction with the long line to Darwin, leads to some high and extremely high voltage periods. This has significantly increased in comparison to 2018-19 where high voltages are occurring more than 70% of the time. Entura considers this to be quite concerning. Power Services advises the Darwin-Katherine power system voltage management strategy is currently being reviewed in conjunction with plans to install inductive compensation to lower voltages in zone substations. This is expected to be completed by the end of 2021.

Figure 16 and Figure 17 show the steady state voltage distribution for the Darwin and Katherine regions in 2019-20, respectively.

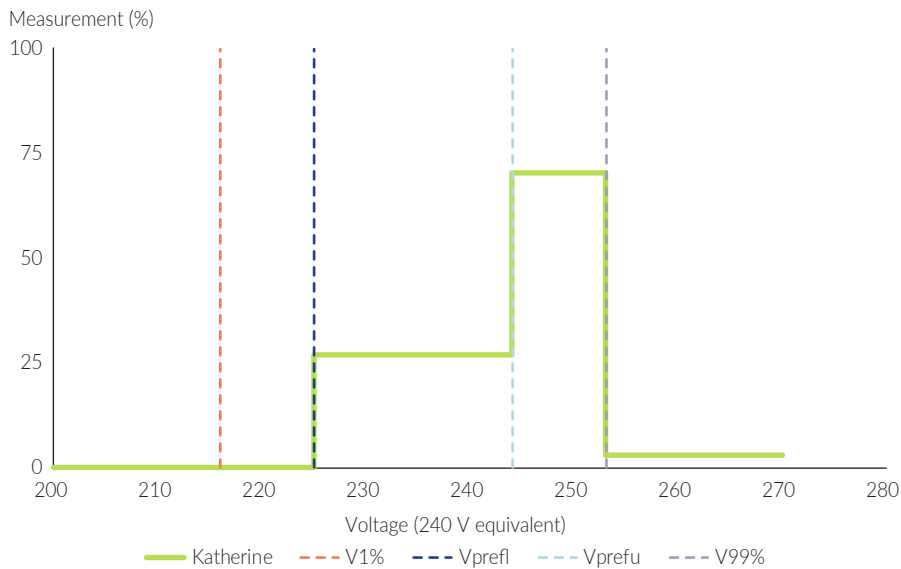
Figure 17: Steady-state voltage performance, Katherine

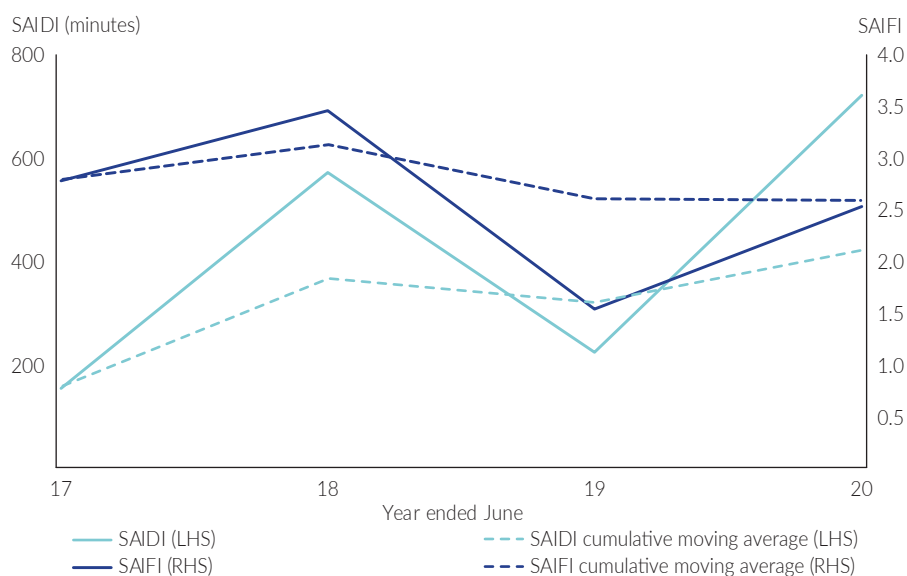
Figure 19: Overall SAIDI and SAIFI performance indices, Alice Springs¹⁵

The overall performance of the power system in 2019-20 is the worst in comparison with the previous three years due to the system black occurring on 13 October 2019, as shown in Figure 19.

The 2019-20 period shows an increase in SAIFI from the previous year although it remains less than the level from 2015-16 to 2017-18. The extended outage caused by the system black in October 2019 contributed to a significant increase in SAIDI in 2019-20.

The performance of the Alice Springs power system continues to be inconsistent as seen in Figure 19. Points to note are the small numbers of customers affected but the high number of customer minutes without supply. This suggests there is an imbalance across the power system in terms of customer experience, although the imbalance may be reasonable depending on the circumstances, with the relativities between customer connection types managed through feeder type performance targets.

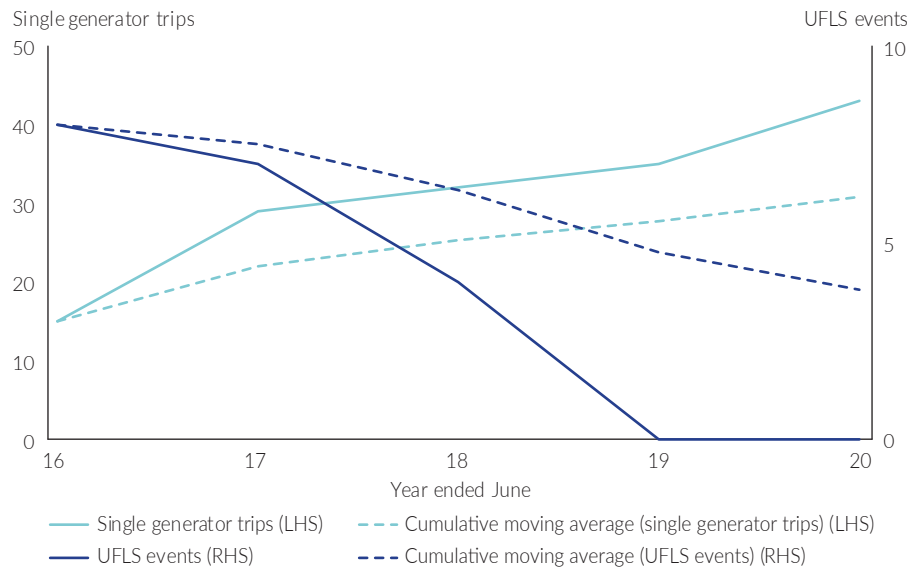
Figure 21: Alice Springs single generator trips versus UFLS (due to single generator trips)

Following on from 2018-19, the Alice Springs power system continues to eliminate UFLS events from single generator trips in 2019-20. Maintaining zero UFLS operations two years in a row is a great result from the customer's perspective. However, the number of single generator unit trips continues to increase. The incidence of these trips continues to be a concern for Entura especially when the trip occurrences have materially increased from the previous two reporting periods in number and distribution. In this respect, it is evident that performance has declined in comparison to previous years.

The combination of running aged machines at the Ron Goodin power station and running Jenbacher machines, in which Territory Generation are still overcoming installation issues, has led to a decline in power system performance. Entura notes Territory Generation is actively working to resolve the issues with both power stations.

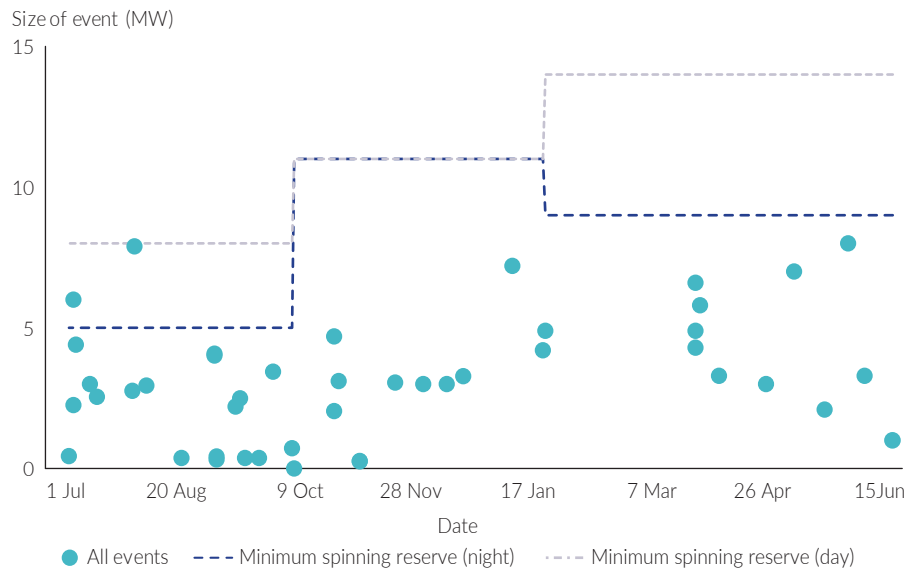
Figure 22: Alice Springs single generator trip by size

The size of single generator trips compared with the day/night minimum spinning reserve in Alice Springs, which changed twice during 2019-20, is shown in Figure 22.

Due to the system black event in October 2019, System Control modified the spinning reserve requirements to ensure system security. Directly after the incident the day and night minimum spinning reserve were increased to 11 MW, and then from February 2020 the day and night minimum spinning were nominated at 14 MW and 9 MW, respectively. Figure 22 illustrates that in the second half of 2019-20, all generator unit trips were well below the night minimum spinning reserve. Inherently this is a good result, however Entura considers it may indicate the nominated minimum spinning reserve may be more conservative than required.

The level of spinning reserve required limits the ability of the power system to be dispatched with a high percentage of capacity provided by the newer Jenbacher generators, which are very high efficiency reciprocating engines. This is due to engines of this type, regardless of equipment supplier, not being able to rapidly accept or reject load, such as during a contingency event. This makes this type of generator generally inappropriate for the provision of large amounts of spinning reserve from a single machine. This results in a higher spinning reserve amount being required to ensure sufficient governor response to meet the contingency requirement, in the absence of other solutions.

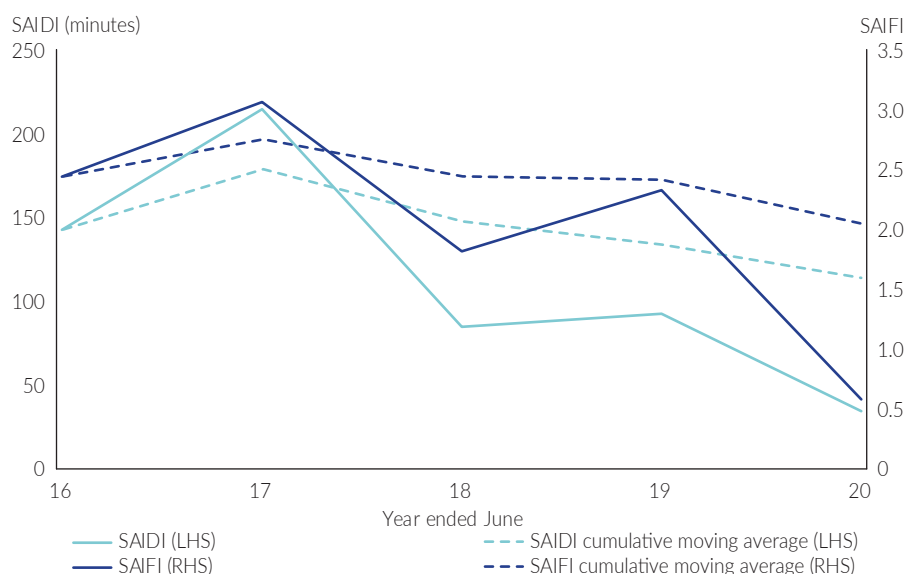
Figure 26: Adjusted SAIDI and SAIIFI performance indices for the Alice Springs network¹⁷

Network performance is measured and reported by Power Services as part of EIP Code requirements. The SAIDI and SAIFI performance for the Alice Springs network is presented in Figure 26.

Both indices remain below the cumulative moving average in 2019-20, with a sharp fall in SAIDI and SAIIFI in comparison with 2018-19. Using the short rural feeder global target as a reference, both indices are well within that benchmark. Further, both the SAIDI and SAIIFI results achieve the higher urban feeder benchmark.

Entura notes there has been no transmission level (66 kV lines) outages in Alice Springs across the last five financial years. This is an excellent result, however Entura is concerned the change in operation in the network associated with the eventual decommissioning of the Ron Goodin power station may lead to some unexpected network incidents in the future. Entura expects the Power System Controller to work to pre-empt these issues where possible.

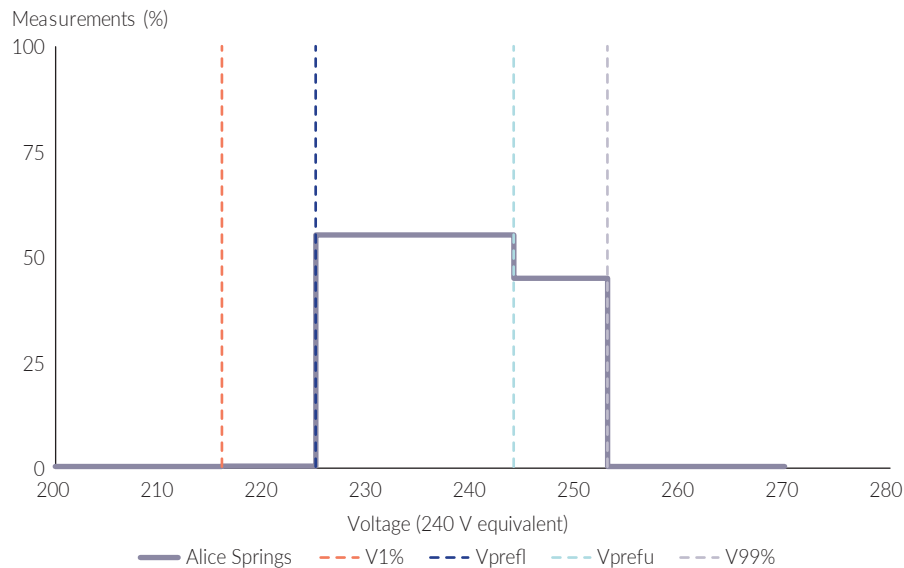
Figure 29: Steady-state voltage performance, Alice Springs

Figure 29 shows the steady-state voltage distribution for the Alice Springs region in 2019-20.

Voltage regulation in 2019-20 is comparable to 2018-19, where voltages are in the preferred zone around 55% of the time. The Alice Springs network topology does not lend itself to strong voltage regulation. This is particularly true when the generating units at the Ron Goodin power station are not dispatched. The distance from the Lovegrove zone substation to the Owen Springs power station means a lot of charging and or line drop must be managed at Lovegrove. It seems this is not possible. The relatively high penetration of behind-the-meter rooftop solar PV in the Alice Springs urban area will also contribute to the high percentage of time the customers experience higher than preferred voltages. These issues must be resolved.

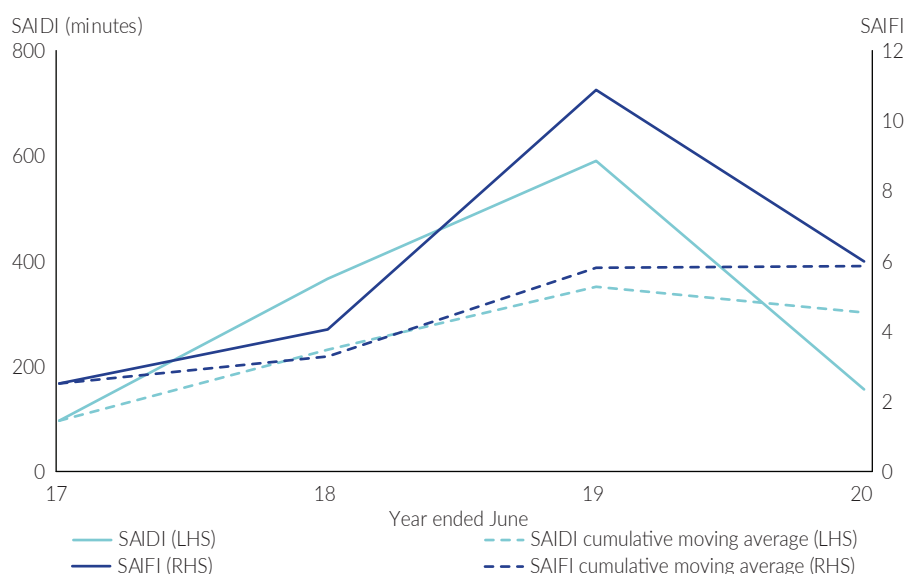
Figure 30: Overall SAIDI and SAIFI performance indices, Tennant Creek²⁰

Tennant Creek performance is improving against each of these indices. The sharp fall in SAIDI and SAIFI in 2019-20 from 2018-19 is shown in Figure 30.

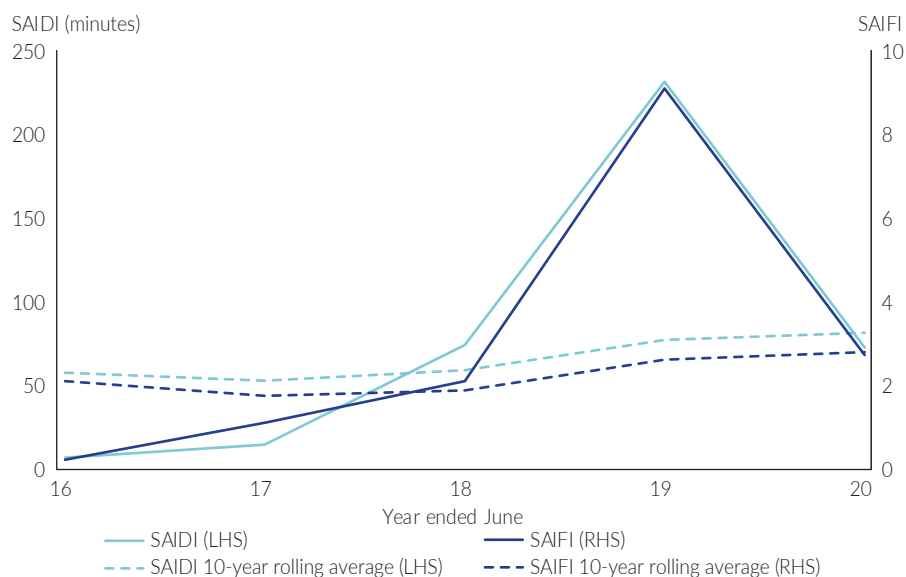
Figure 31: SAIDI and SAIFI performance indices for generation, Tennant Creek

The SAIDI and SAIFI performance for the Tennant Creek generating units is shown in Figure 31.

The performance in 2019-20 was a significant improvement from 2018-19, with the SAIDI and SAIFI below the 10-year average. The improvement can be attributed to changed operational approaches due to continued difficulties with the new Jenbacher generation units.

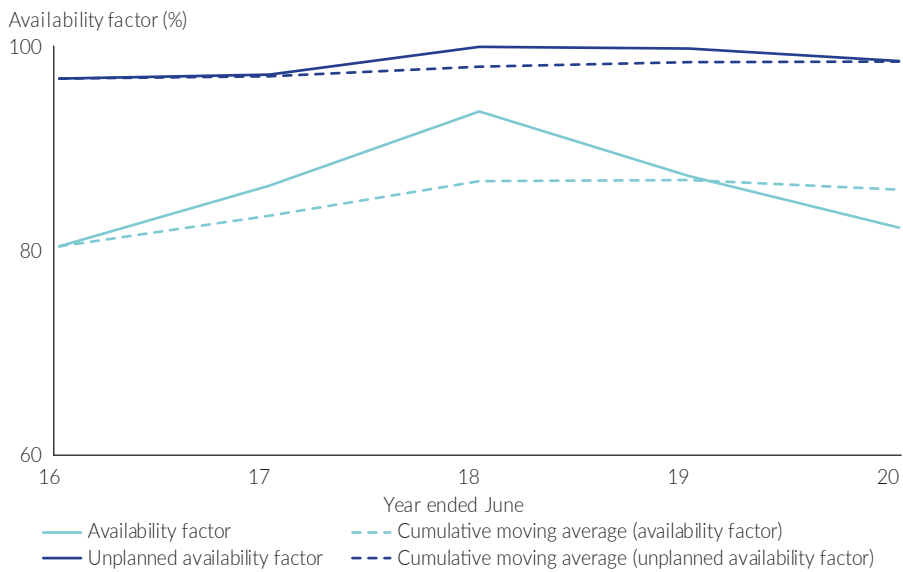
Figure 32: Availability and unplanned availability factors for generation, Tennant Creek

Figure 32 shows the availability and unplanned availability factors for the Tennant Creek power system over the last five years.

The availability of generators in the Tennant Creek power system has continued to decrease in 2019-20, however this is largely driven by an increase in planned maintenance over the last two years, from a low in 2017-18. While this is positive in terms of showing a higher level of preventative maintenance and or withdrawal from service of units of questionable reliability, it does reduce the amount of capacity available to support the Power System Controller in managing a reliable and secure system. However, this is likely mitigated by the large amount of installed capacity in Tennant Creek compared with the level of system demand.

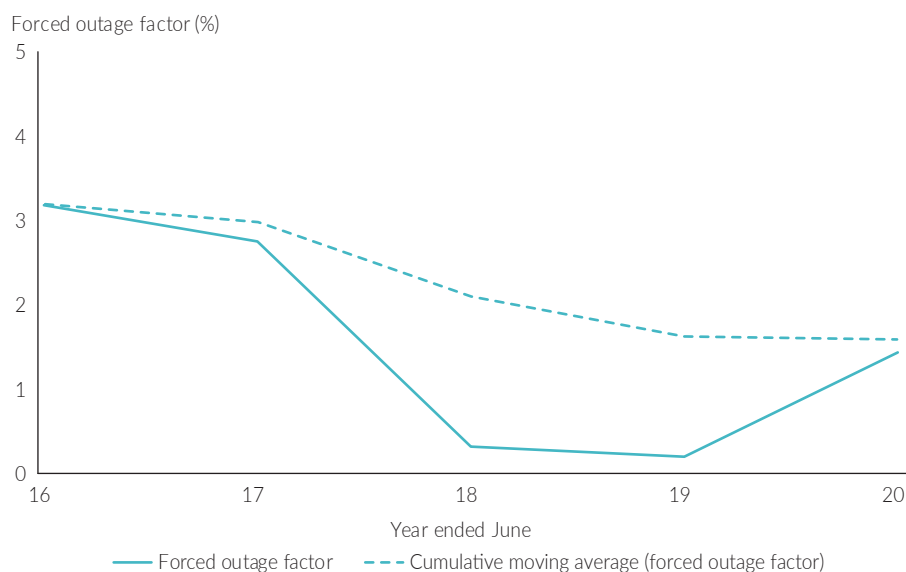
Figure 33: Forced outage factor for generation, Tennant Creek

Figure 33 shows the forced outage factor for the Tennant Creek power system over the last five years.

The forced outage factor has risen in 2019-20 compared with the previous two years, however remains under the cumulative moving average. Tennant Creek is a challenging power system to operate, however these challenges are significantly reduced when the generating units are reliable or managed so that unreliability does not lead to unplanned outages.
