# Northern Territory Power System Performance Review

2020-21

# About this review

The 2020-21 NTPSPR is prepared in accordance with section 45 of the *Electricity Reform Act 2000* and is restricted to the Darwin-Katherine, Alice Springs and Tennant Creek power systems.

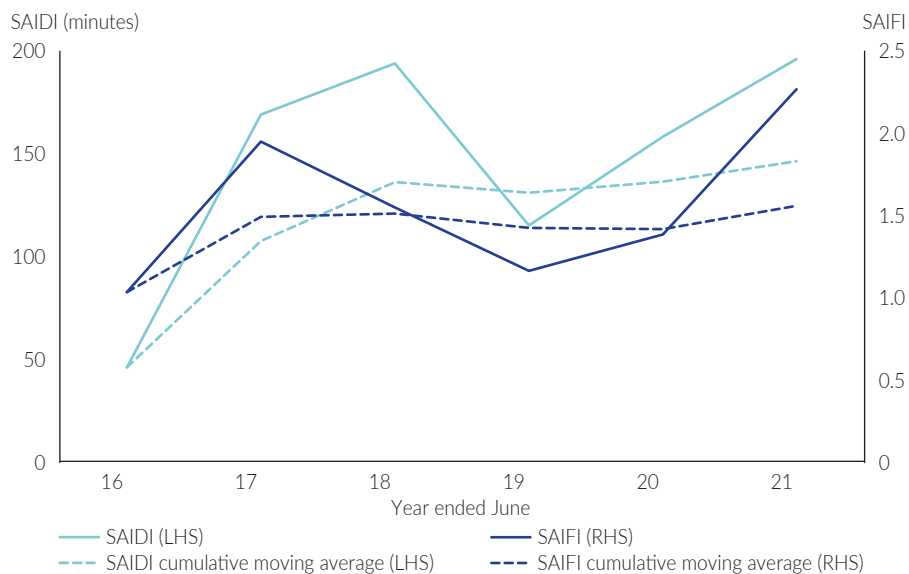
The major and minor incident SAIDI and SAIFI performance for the Darwin-Katherine power system over the last six years is shown in Figure 2.

Figure 2: Major and minor incident SAIDI and SAIFI performance, Darwin-Katherine<sup>8</sup>

There was a large increase in SAIDI and SAIFI during 2020-21 compared with 2019-20. Based on the rolling average, both SAIDI and SAIFI are continuing to deteriorate. However, Entura notes an incident on 18 November 2020 resulting in the loss of gas supply to the Channel Island power station, and subsequent technical black<sup>9</sup>, strongly impacted the result in 2020-21 and accounted for 82% of the SAIDI when considering major incidents (55% of the 2020-21 SAIDI when considering both major and minor incidents).

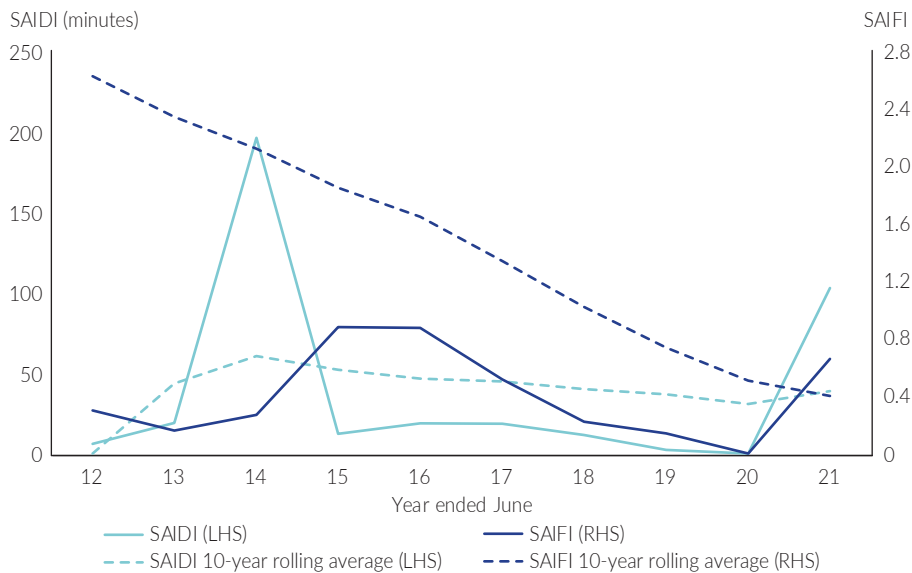
Generation performance for the Darwin region is shown using the SAIDI and SAIFI indices (see Figure 5).

Figure 5: SAIDI and SAIFI performance for generation, Darwin

SAIDI and SAIFI have considerably increased in 2020-21, with SAIDI and SAIFI levels rising to the highest levels in the last five years. Despite this, the 10-year rolling average for SAIFI continues to decline, while for SAIDI, the 10-year rolling average slightly increased. Entura notes a single technical black event, caused by gas supply interruption to the Channel Island power station, contributed about 55% of the 2020-21 SAIDI result. Given that Territory Generation reported a SAIDI of zero in the Darwin region during 2019-20, Entura considers that had the technical black not occurred, performance of generation in the Darwin region would still have declined during 2020-21. This is despite a decrease in the number of single unit trips in comparison to 2019-20. The number of single generator unit trips is discussed in the following section.

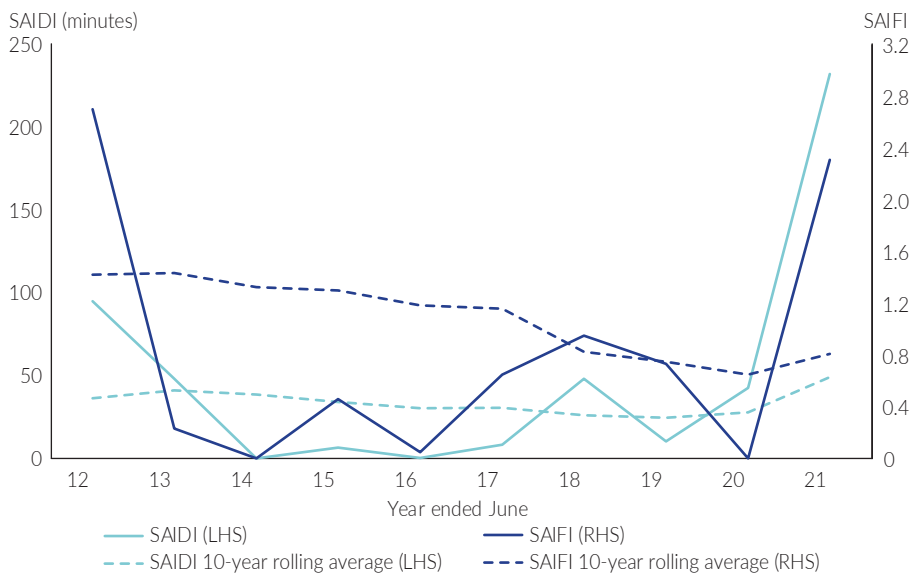
SAIDI and SAIFI are compiled for the generating units in the Katherine region separately (Figure 6).

Figure 6: SAIDI and SAIFI performance for generation, Katherine

SAIDI and SAIFI show a significant deterioration from 2019-20. SAIFI has increased to levels comparable to those of 2011-12, while SAIDI in 2020-21 is the worst result over the last 10 years and is above the 10-year average by a substantial level, as shown in Figure 6. The trend for both indices changed trajectory in 2020-21 with the 10-year rolling average starting to increase.

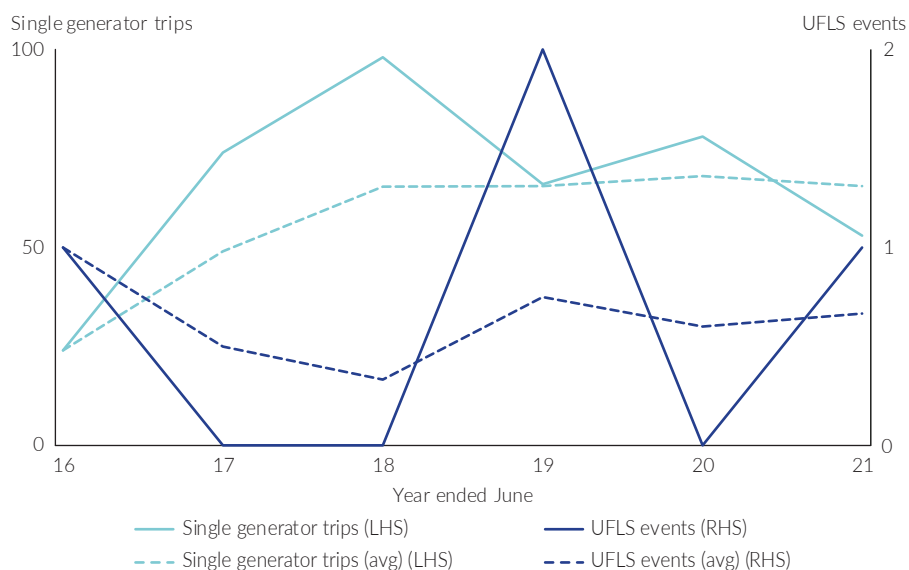
PWC System Control biannual reports<sup>17</sup> to the Commission show a decline in unit trips during 2020-21, as shown in Figure 7.

Figure 7: Darwin-Katherine single generator trips versus UFLS (due to single generator trips)

In 2020-21, the number of single unit trips decreased from 2019-20, with only one leading to a UFLS incident. Entura considers the change in trajectory of the trend in generator trips to be a good result. Regardless, the number of single unit trips may represent an unacceptable lack of robustness in the generation fleet, as observed in previous reviews.

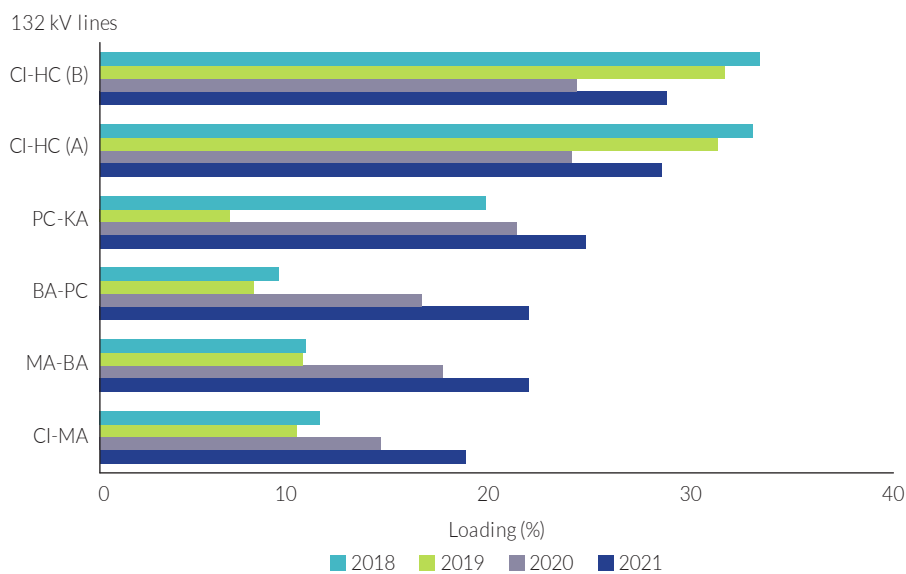
The maximum demand transmission network utilisation during 2020-21 is shown in Figure 11.

Figure 11: Transmission network utilisation Darwin-Katherine (132 kV)

132 kV line loadings remain well within rating. Entura make this assessment on the following basis:

- parallel lines such as the CI-HC lines do not exceed 50% of their rating and so can be considered to run firm. This means that in normal operation, one of the lines could trip due to a fault and full flow could be maintained on the other line
- other lines are below their rating. The remaining lines are essentially radial and run from Channel Island through Manton, Bachelor and Pine Creek to Katherine. Therefore, they must operate at or below their rating but are not required to provide increased flow in the event of a contingency.
- The addition of new solar PV generation south of Channel Island is likely to lead to higher flows on the CI-MA and MA-BA lines in coming years. There is currently spare thermal capacity on those lines to allow for some additional generation in that region.

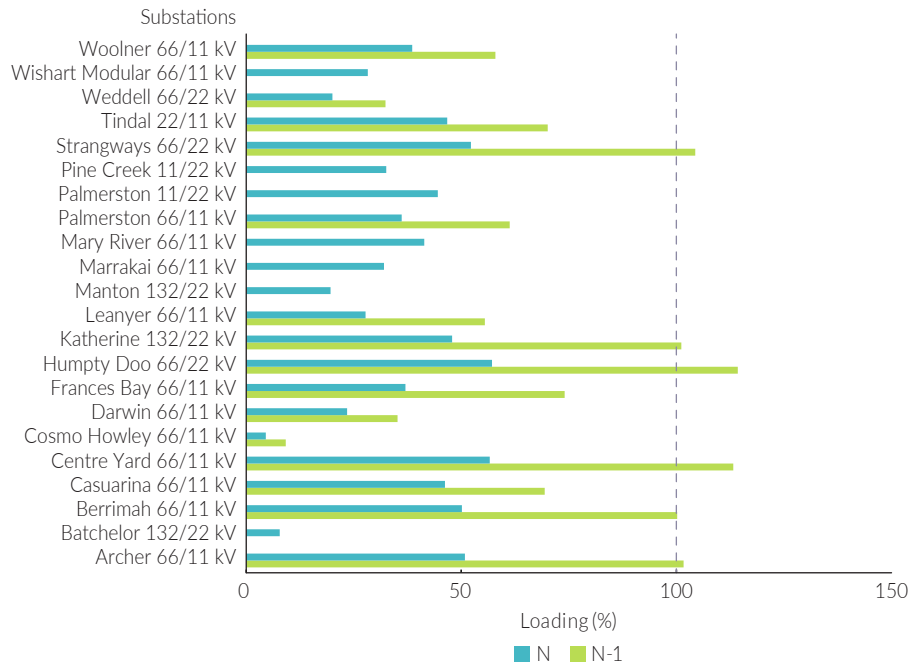
The zone substation transformer loading under N and N-1 conditions for 2020-21 is shown in Figure 13. The zone substations of concern in the figure are those where either the N (for substations with single and multiple power transformers) or N-1 (for substations with multiple power transformers) loading exceeds 100%.

Figure 13: Substation utilisation for N and N-1 conditions Darwin-Katherine

The figure above shows actual zone substation loading in 2020-21. On the basis that substation loading on either N or N-1 should not exceed 100%, in 2020-21 Strangways, Katherine, Humpty Doo, Centre Yard and Archer zone substations were at risk of not fully supplying the substation load had one transformer gone out of service (N-1). Strangways and Archer zone substations were just below 100% capacity for N-1 operation in 2019-20, however due to an increase in demand this has now been exceeded. Berrimah is expected to exceed N-1 capacity in 2021-22. PWC Power Services indicated the assets at Berrimah are approaching end of life and are in the process of being replaced. According to the 2021 TDAPR this replacement will be completed by 2023-24.

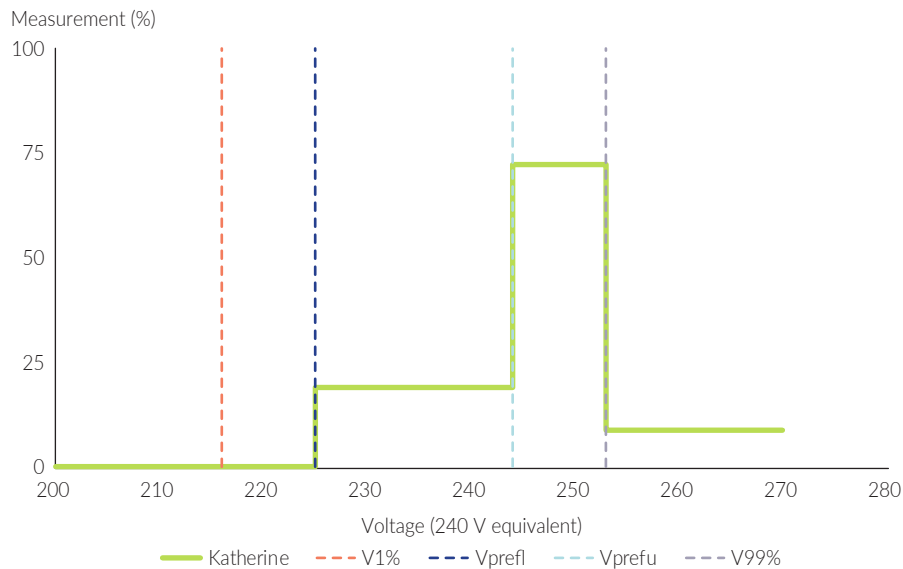
Figure 16: Steady-state voltage performance, Katherine

In contrast to the Darwin region, in the Katherine region PWC Power Services reported a lack of buck (voltage reducing) taps on the transformers, in conjunction with the long line to Darwin leads to some high and extremely high voltage periods. In 2020-21, the voltage in the preferred zone (that is, between  $V_{prefl}$  and  $V_{prefu}$ ) has decreased from 27% to 19% compared with 2019-20, and high voltage periods have increased from 70% to 72% while extremely high voltage periods have increased from 3% to 8%. Entura therefore concludes the voltage in the Katherine region is higher during 2020-21. This continues to be a concern. PWC Power Services has advised that the Darwin-Katherine power system voltage management strategy is currently being reviewed in conjunction with plans to install inductive compensation to lower voltages in zone substations, with the development stage of this project expected to be completed by the end of 2021. Additionally, PWC Power Services has introduced new technical specifications for connection of embedded generation that requires solar PV and batteries to assist in mitigating voltage rise.

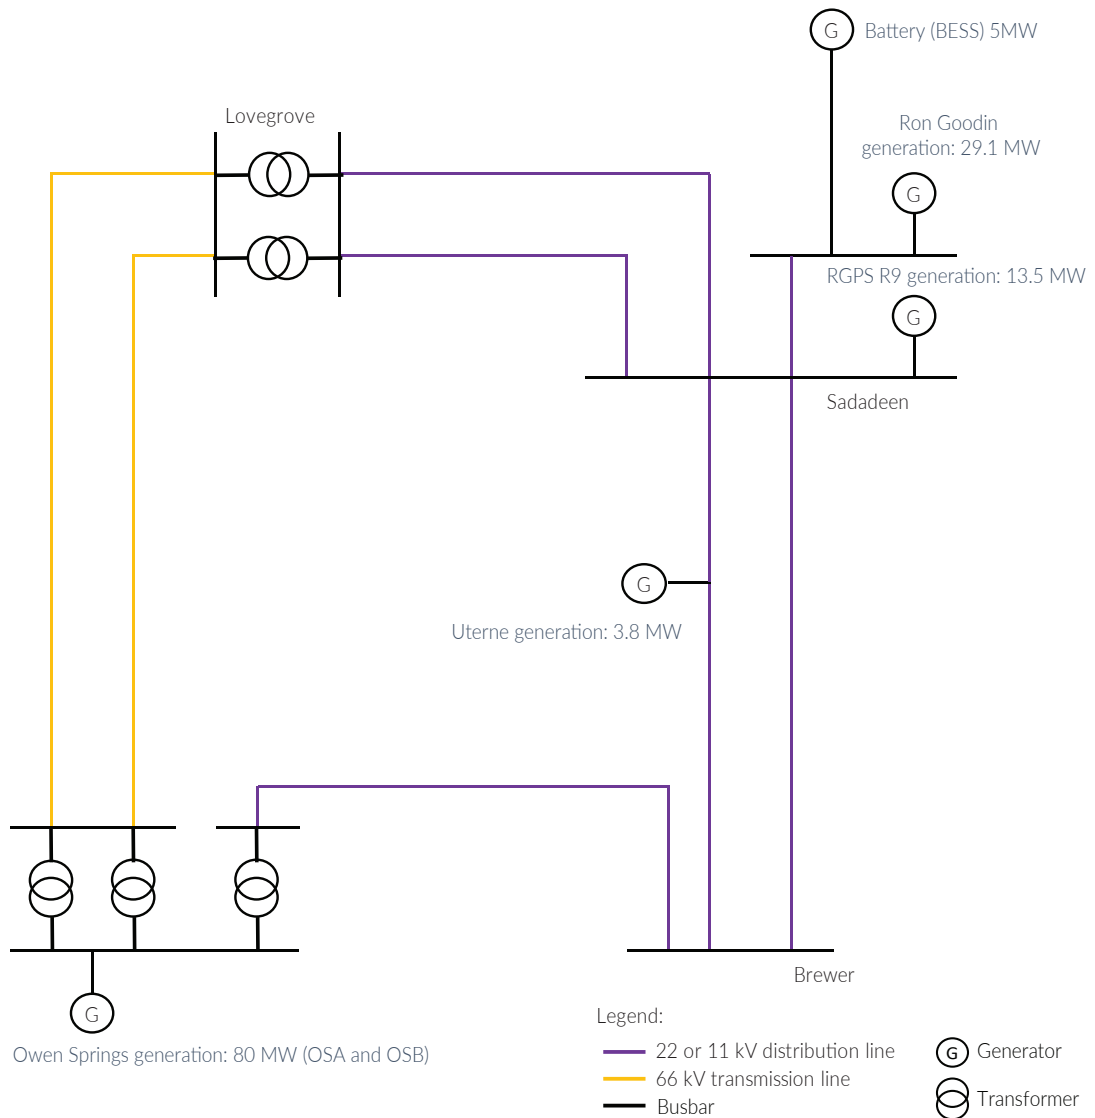
Figure 17 shows a simplified representation of the Alice Springs power system. The highest voltage of the network is 66 kV.

Figure 17: Alice Springs power system<sup>24</sup>

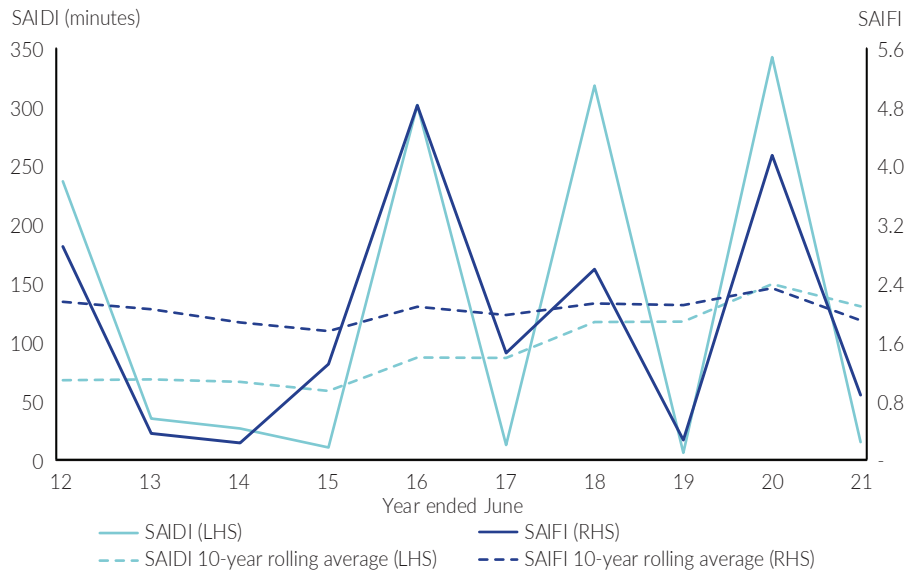
Figure 19: SAIDI and SAIFI performance for generation, Alice Springs

The two indices demonstrate the number of issues that have beset the Alice Springs power system over the last 10 years. It can be observed that the generation SAIDI and SAIFI improved in 2020-21, however the indices have been extremely volatile over the last 10 years.

Entura has been expecting the generation upgrades at the Owen Springs power station and the full commercial operation of the BESS to improve the performance. Unfortunately, these upgrades are yet to meet this expectation in a consistent manner.

Generation performance for the Alice Springs power system is shown using the SAIDI and SAIFI indices (see Figure 19).

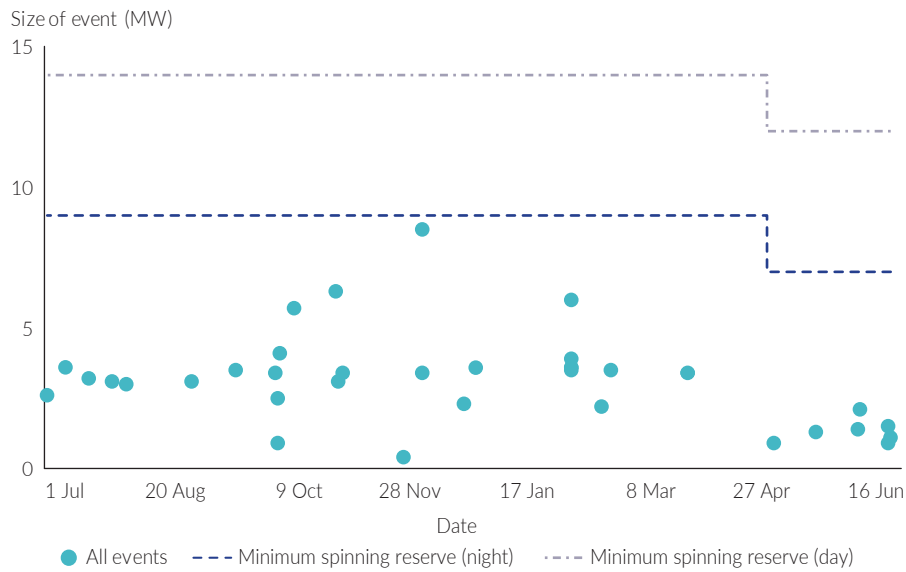
Figure 21: Alice Springs single generator trip by size

The spinning reserve at the beginning of 2020-21 was nominated at 14 MW for day time operation and 9 MW for night time operation. In May 2021, the minimum spinning reserve was reduced by PWC System Control to 12 MW and 7 MW for day and night time operation, respectively. The margin between an event size and the minimum spinning reserve can be misleading as there may have been a generating unit dispatched at a higher power output that did not trip, however Entura considers the minimum spinning reserve to be adequate for the events that occurred during 2020-21.

The size of single generator trips compared with the day and night minimum spinning reserves in Alice Springs, which changed during 2020-21, is shown in Figure 21.

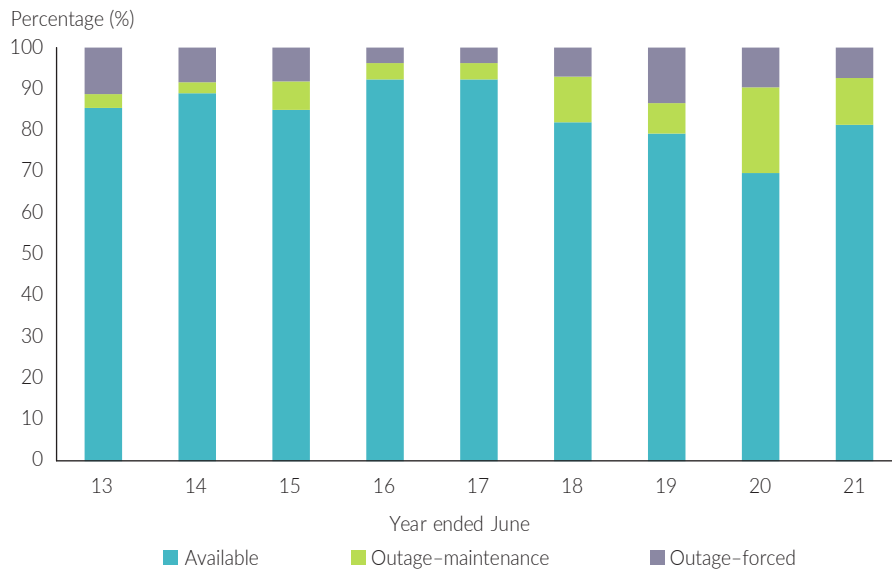
Figure 22: Capacity weighted Alice Springs generation availability

Generation availability improved in 2020-21 compared with 2019-20, however, although not shown, the rolling average continued to fall due to inconsistent generation availability over the last nine years.

Generation forced outages in the Alice Springs power system dropped in 2020-21, however still remained at a high level compared with the previous years and, although not shown, was still higher than the rolling average. It appears generation forced outages are still on the upward trend. Forced outages vary considerably year on year and it is more appropriate to consider the rolling average, which suggests a decline in performance.

Figure 22 combines the indices reported by generators in the Alice Springs power system to show the capacity weighted generation availability in the region over the last nine years, including the level of both planned maintenance and forced outages.

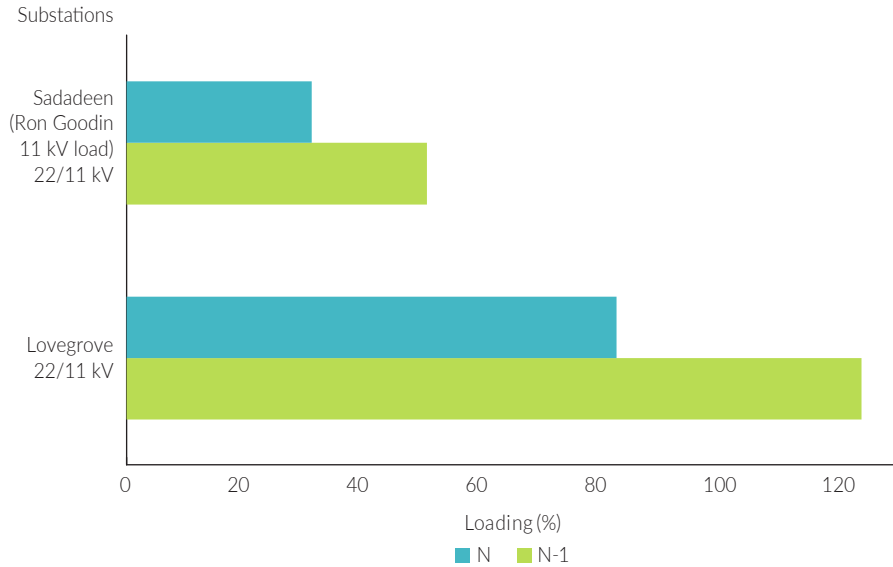
Figure 25: Substation utilisation for N and N-1 conditions, Alice Springs

Figure 25 shows actual zone substation loading in 2020-21. On the basis that substation loading should not exceed 100%, in 2019-20 the Sadadeen 22/11 kV substation was at risk of not fully supplying the substation load if one transformer went out of service (N-1). However, this switched to the Lovegrove 22/11 kV substation in 2020-21. Entura understands that load can be transferred between these two zone substations following a failure of one of the Lovegrove transformers. However, upgrades are required at Lovegrove to improve the cyclic rating so customers can be supplied during the transfer process.

The zone substation transformer loading under N and N-1 conditions in 2020-21 is shown in Figure 25.

Generally, where a zone substation has multiple transformers, it is expected a substation can supply the full substation load with one transformer out of service (N-1). The substations of concern in the figure are those where either the N or N-1 loading exceeds 100%.

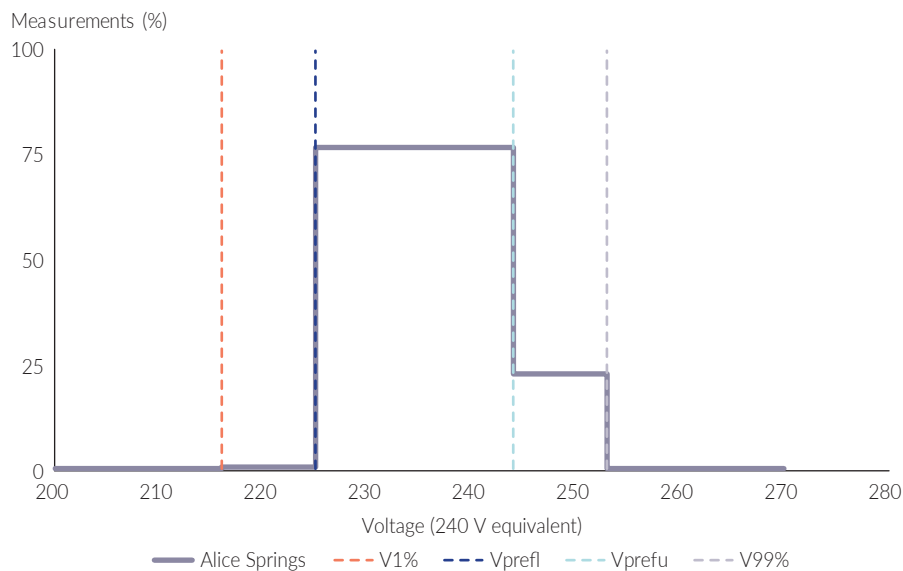
Figure 27: Steady-state voltage performance, Alice Springs

Voltage regulation has improved in 2020-21 in comparison to 2019-20, with voltages in the preferred zone rising from 55% to 77%. The high voltage periods have also decreased from 44% to 23%.

The improvement appears to mostly relate to commissioning a third transformer at the Sadadeen zone substation that has decreased the impedance in the network and therefore enhanced voltage control. The voltage remains above the preferred range for about a quarter of the time. Entura understands PWC Power Services is considering the management of voltage in the Alice Springs region carefully and will consider further augmentations as required.

Figure 27 shows the steady state voltage performance for the Alice Springs region in 2020-21.

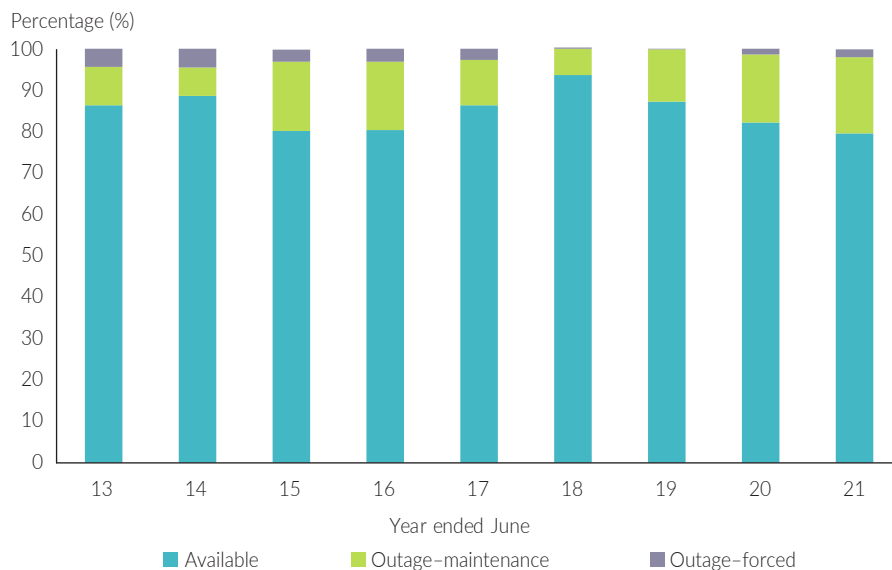
Figure 30: Tennant Creek generation availability

The availability of generators in the Tennant Creek power system has continued to decrease in 2020-21, however the main contributing factor to this reduction is an increase in planned maintenance, and to a lesser extent, a slight increase in forced outages. While the increase in planned maintenance is positive in terms of showing a higher level of preventative maintenance and or withdrawal from service of units that are of questionable reliability, it does reduce the amount of capacity available to support PWC System Control in managing a reliable and secure system. This is likely mitigated by the large amount of installed capacity in Tennant Creek compared with the level of system demand.

Figure 30 combines the indices reported by generators in the Tennant Creek power system to show the capacity weighted generation availability in the region over the last nine years, including the level of both planned maintenance and forced outages.

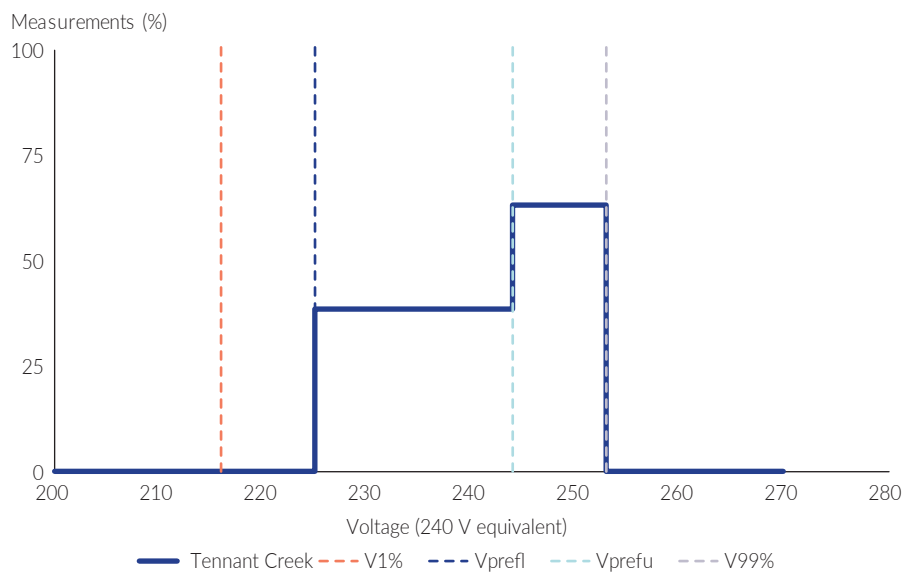
Figure 33: Steady-state voltage performance, Tennant Creek

This is the first year low voltage quality data has been reported by PWC Power Services in relation to the Tennant Creek network.

During 2020-21, data indicates voltage was in the preferred zone for about 38% of the time and high voltage periods accounted for 62%. Similar to the Alice Springs network, voltage regulation is an ongoing challenge in the Tennant Creek network given the long lightly loaded distribution feeders.

Figure 33 shows the steady state voltage performance for the Tennant Creek region in 2020-21.

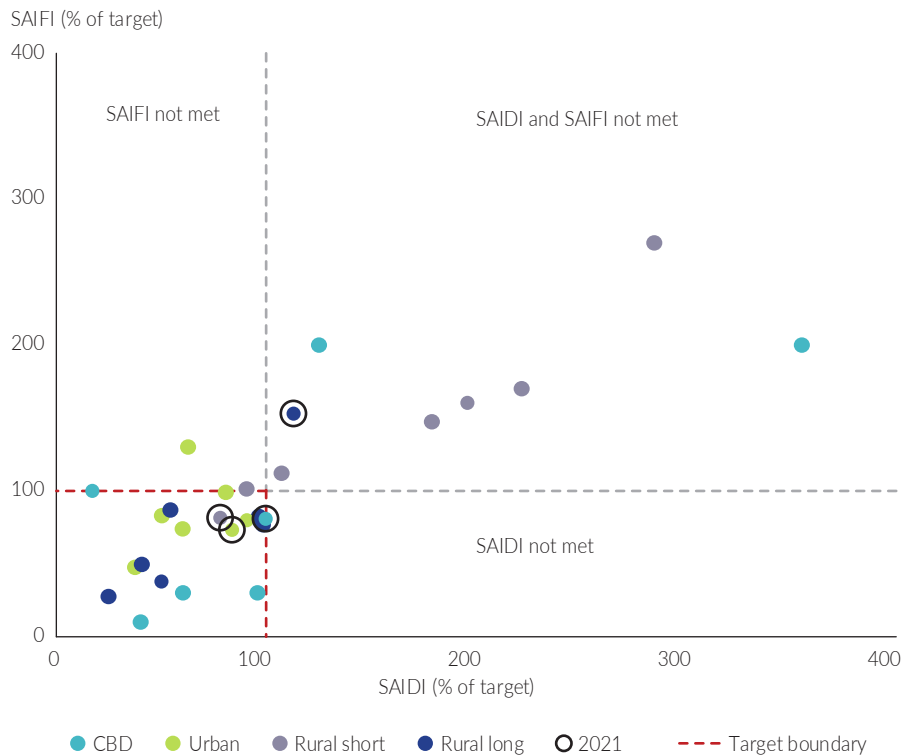
Figure 34: Feeder performance by feeder type

The Figure 34 shows that generally the SAIFI and SAIDI targets are met for the rural long and urban feeders, however, in 2020-21 the SAIFI and SAIDI targets were not met for rural long feeders. The CBD performance has varied across the last seven years, with 2020-21 SAIDI marginally under target. The rural short feeder performance has improved with both SAIDI and SAIFI targets met for the first time in seven years.

The results are shown graphically in Figure 34.
